# St Andrews Church, Keighley: Monuments Condition Assessment and Relocation Methodology

Author: Valerio Caputi, MA, Head Conservator for Pinnacle Conservation Ltd  
Lev 7 Cultural Heritage Conservator, Icon Pathway Member

Date of inspection: 10/02/2026

Property address: 8 - 10 North Street, Keighley, BD21 3SE

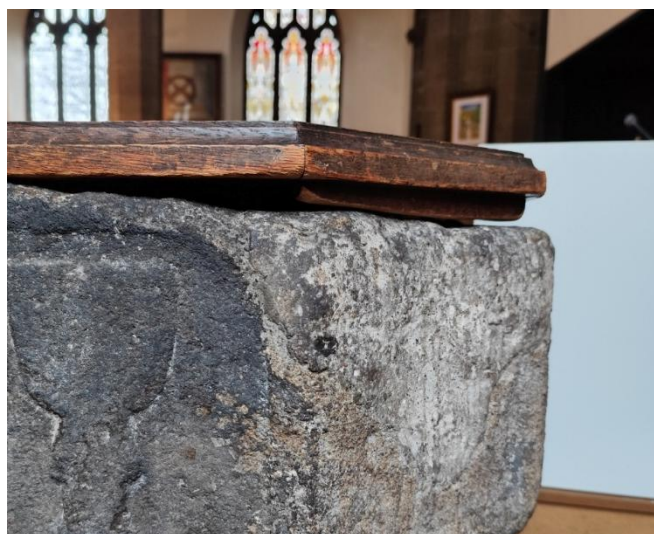
The lid has wooden spacers made to suit the uneven profile of the font, demonstrating that the font was already damaged and repaired upon installation and restoration within the church premises.

*Figure 2 shows the wooden spacer used to support the lid on the uneven surface.*

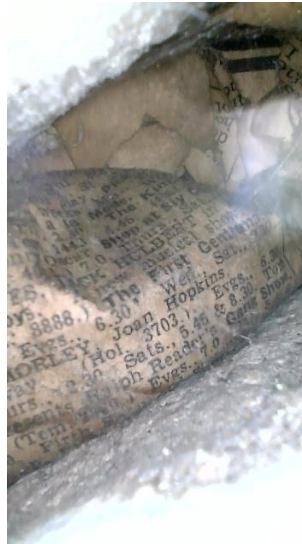
It was found that a printed paper was inserted at the bottom of the font, and there was also the presence of metal, whether this element is a lead used for the water drainage system or a fixing dowel is uncertain.

*Figure 3 show internal printed paper left under the font.*

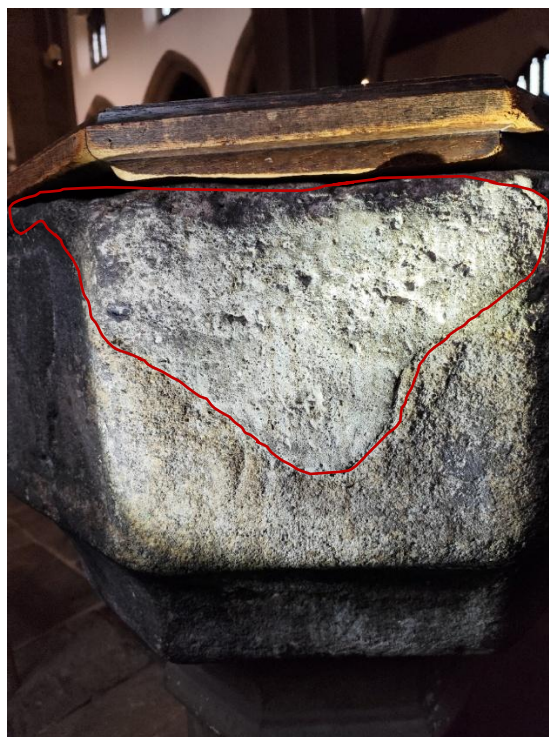
Concerning the original font, all the panels are in good condition, with the exception of the south and southeast panels, where a large patch of mortar is visible.

*Figure 5 show the mortar repair on the east side of the font, highlighted in red.*

Moreover, the surface appeared to be cleaned or abraded, whereas the other sections still present the original patina.

It is recommended that the Font will need to be included in the quinquennial inspection if applicable. The condition of the present mortar repairs should be monitored, and if any change occurs, a qualified conservator should be consulted to offer further recommendations.

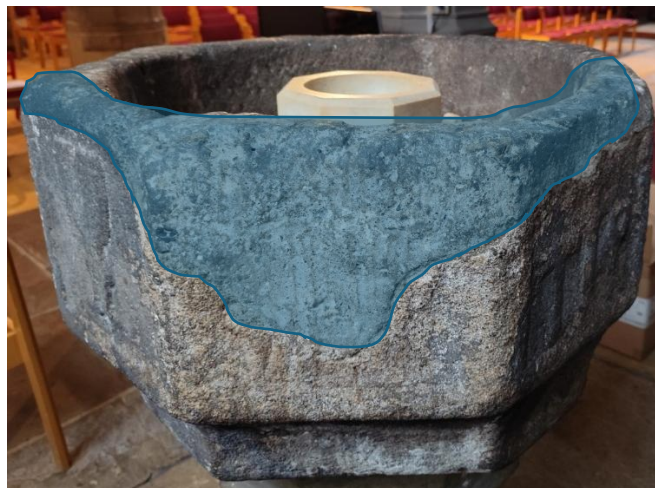
The Font is in stable condition, and there is no evidence of active deterioration. The assessment was carried out using a raking light, UV lamp, and endoscope. There is clear evidence of past interventions, where two different mortars were employed to repair the fabric of the Font.

*Figure 6 show the large area repaired with mortar.*

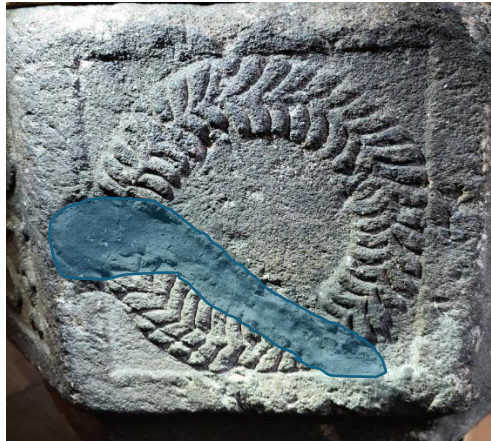
*Figure 7 show the diagonal mortar repair on the original panel.*

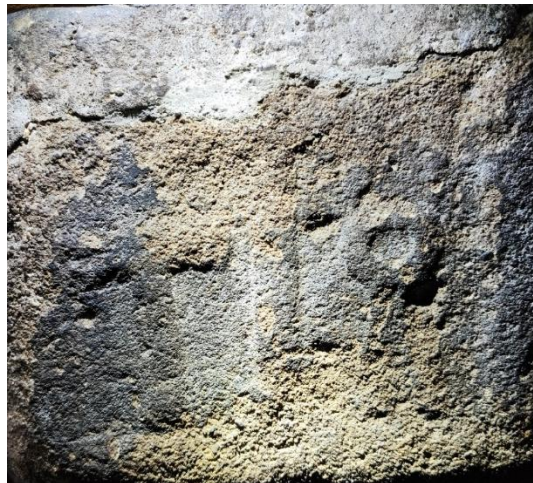
There is also evidence of mechanical damage and abrasion on the east panel, where the original patina does not appear as clearly as for the rest of the object.

*Figure 8 Diffuse abrasion and loss caused the loss of details across this carved panel.*

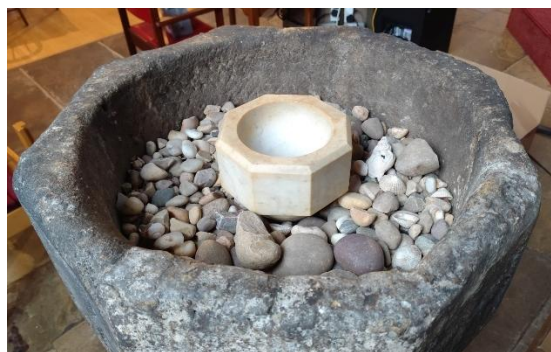
The inspection of the internal section was made particularly difficult due to the presence of stone pebbles and a stone vessel.

*Figure 9 show how the internal section of the font has been filled with pebbles and a water container.*

The Font appears to be occasionally used; whilst this is positive for the intangible heritage related to the object, it poses a risk of water contamination and moisture accumulation within the internal section due to the presence of stone pebbles as substrate, which can be mitigated by using a suitable vessel for the holy water.

The use of a plastic or stainless-steel water vessel is advisable, and this can substitute the current stone vessel in the font to allow usage, whilst offering an easier assessment and cleaning setting to aid future maintenance.

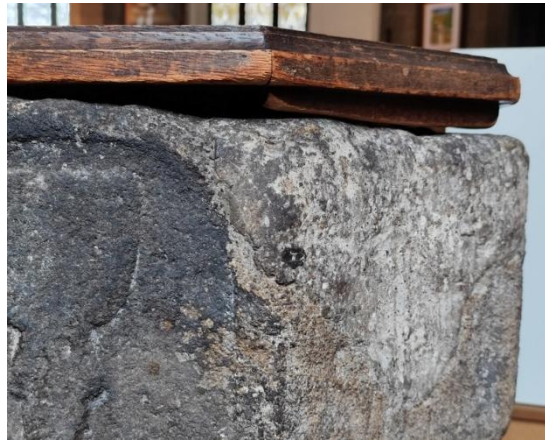
Finally, it was observed that the lid is currently resting on the stone surface. The lid could pose risks of mechanical abrasion of the fabric in the long term.

*Figure 10 shows the lid resting on the stone without any isolation materials.*

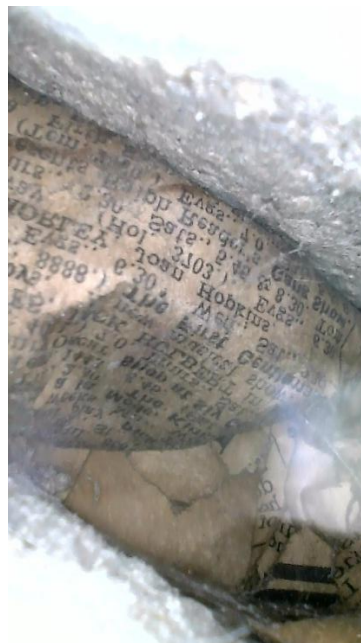
*Figure 11 show the endoscope analysis result with evidence of the printed paper allocated internally.*

This could lead to abrasion within the font and the supporting plinth; the presence of printed paper was also observed during the investigation with the endoscope.

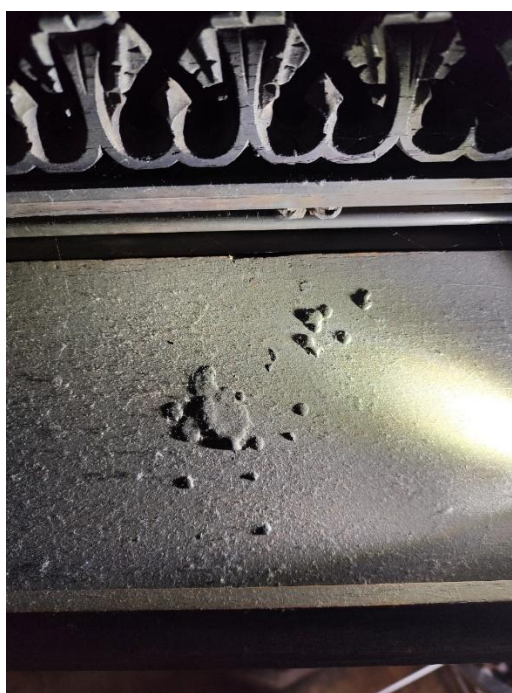
*Figure 16 shows the drops of a resinous material on the canopy.*

darkened. Their condition is stable, and the structure appears to be effectively fixed to the above ceiling. There are a presence of bituminous paint drops on the upper section of the font base, suggesting that restoration works took place above the object.

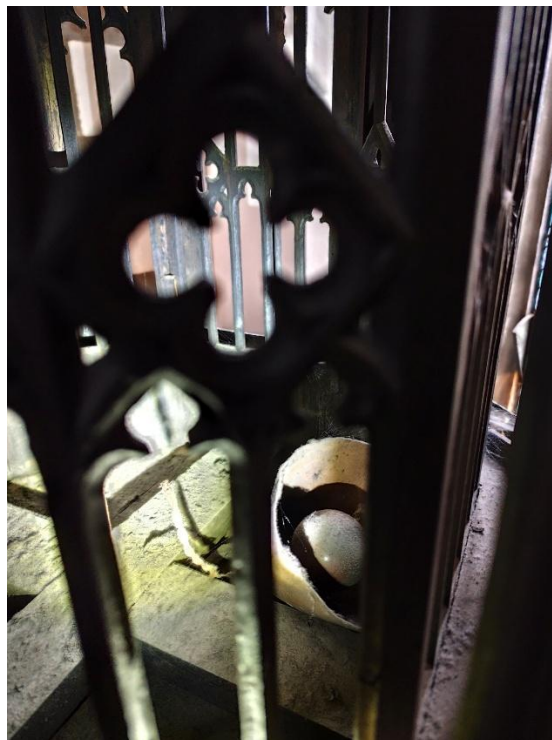
The past intervention and addition of electric and sound systems are likely the main cause of the losses observed.

*Figure 17 redundant light system internally.*

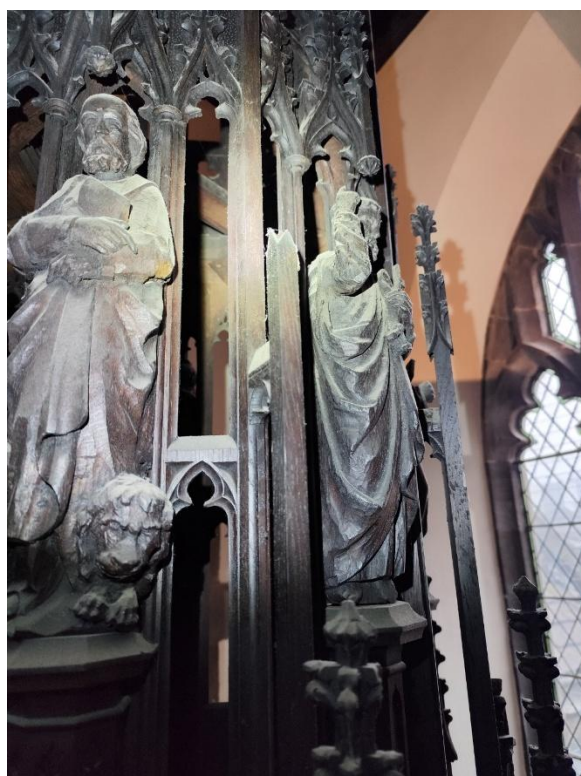
There is evidence of loss across the canopy; these elements could be re-carved in oak or cast in a suitable material to reinstate legibility of the complex design.

*Figure 18 show missing pinnacle on the carved woodwork.*

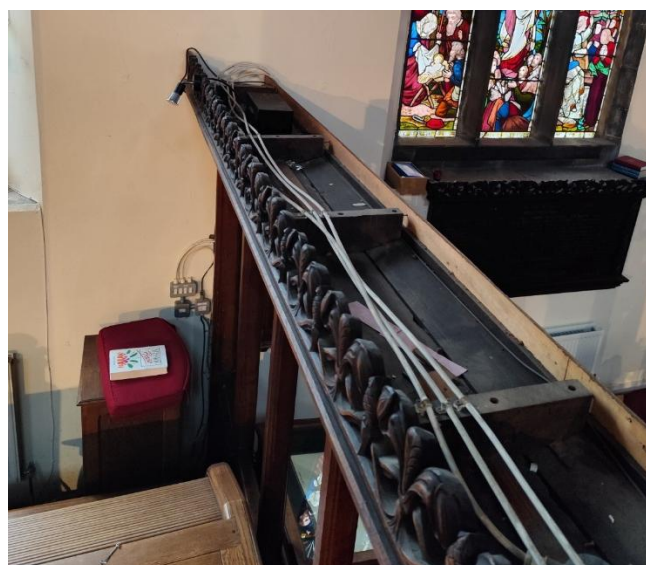
The element is fixed with mortise and tenon joints, and there is the presence of veneer panels on both sides of the structure, hiding internal electric cables, which are also visible on the top of the memorial beam.

Figure 22 it shows the cables on the upper section of the memorial.

It is recommended that the electrical cables be removed from the object.

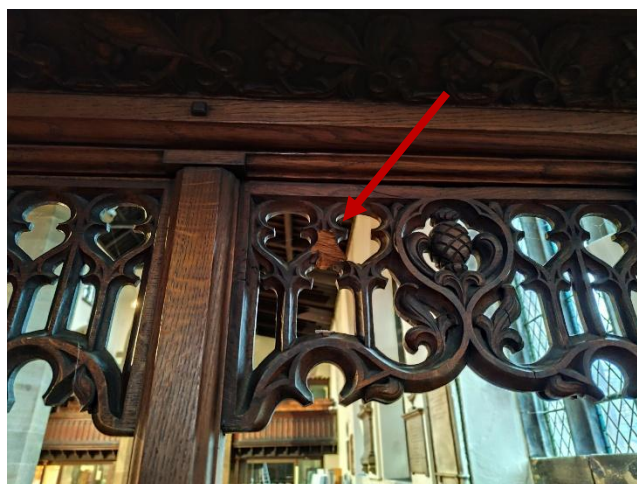
The Memorial is in good condition. It was examined with a step ladder and a portable torch. There is one loss observed across the object, and the varnish is clear and in fair condition. The condition is stable, and the structure is effectively fixed to the wall on both sides.

*Figure 23 show damage to the tracery.*

The damage observed was caused by objects being moved around the church and or general maintenance, to the electrical system. There is no sign of active deterioration, and the object looks clean and stable.

The loss should be repaired if there are available resources with a new oak carved section, and or casting of the original section in a suitable material that can be tinted to match the colour.

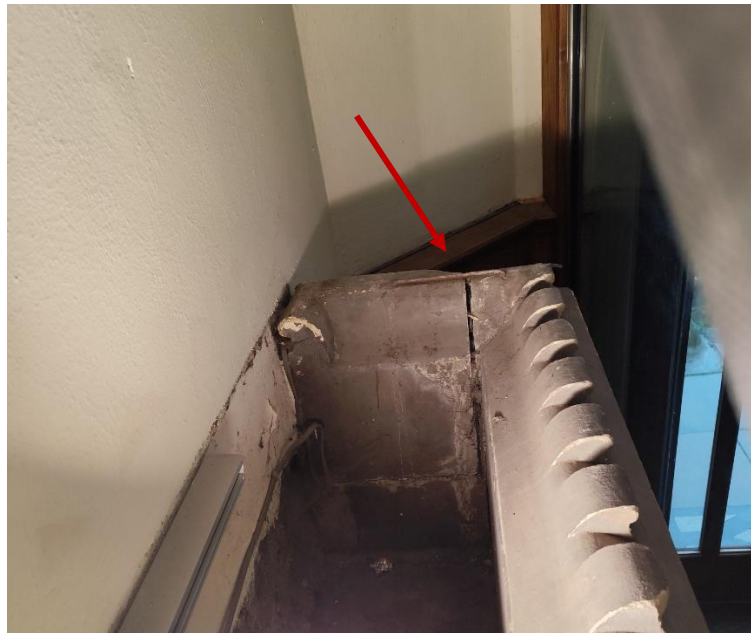
*Figure 29 show the iron supporting the crenelation.*

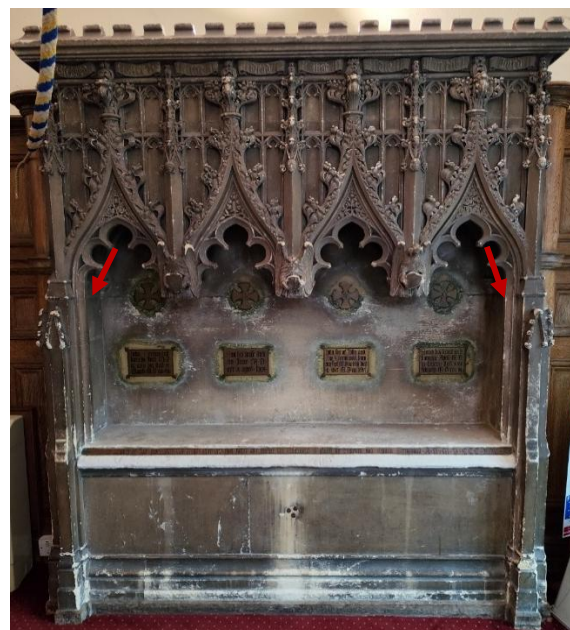
*Figure 30 show the point where metal was detected, likely iron dowels.*

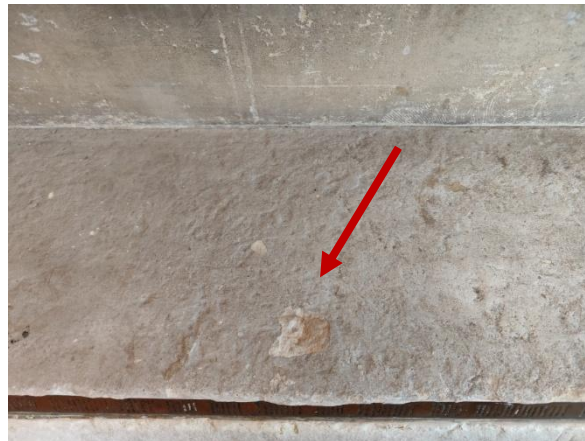
*Figure 31 show the paint flaking in the central area of the stone seat.*

The stone seat was painted in a thick off-white paint, likely to prevent further damage to the area; the composition of this coating is unclear. Moreover, two of the angel carvings are damaged, and the head is missing, repaired in the past using dowels, which are now showing signs of ongoing corrosion. The traceries and the pinnacles present abrasions and minor losses.

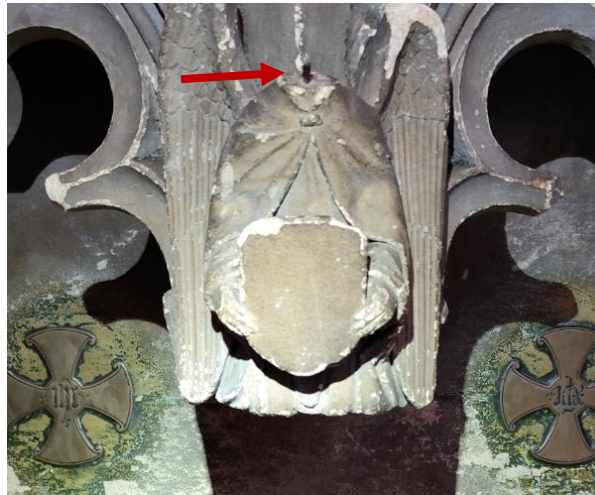
The archival research showed that the monument was dismantled and relocated to the present position. There is also evidence of past intervention, the two iron clamps added to the crenelations, and the iron dowel, once supporting the angel's heads and now exposed.

*Figure 33 show the iron dowel once supporting the missing head.*

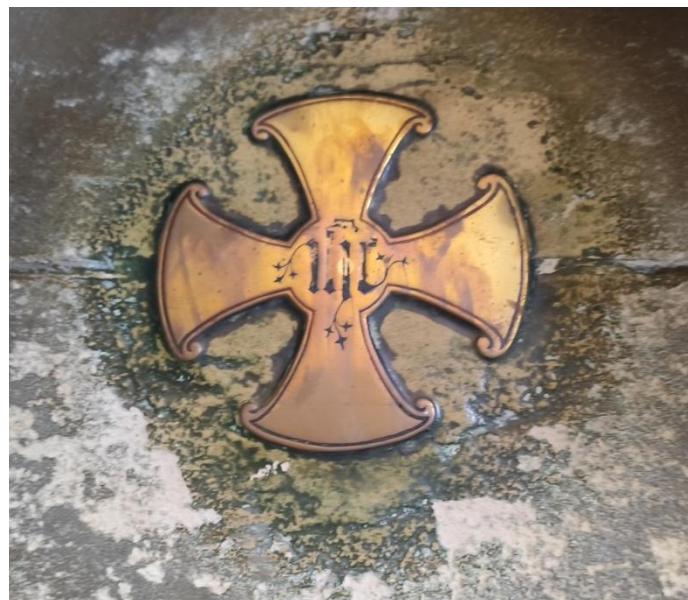
This suggests a phase of previous interventions and restorations, which could be associated with the relocation and or recent history, but remains unclear. Moreover, there is evidence of a past attempt to clean the brass plaques and the use of a varnish to protect them or enhance their appearance.

*Figure 34 show the polished area of the stone adjacent to the cross, suggesting the use of abrasive cleaning.*

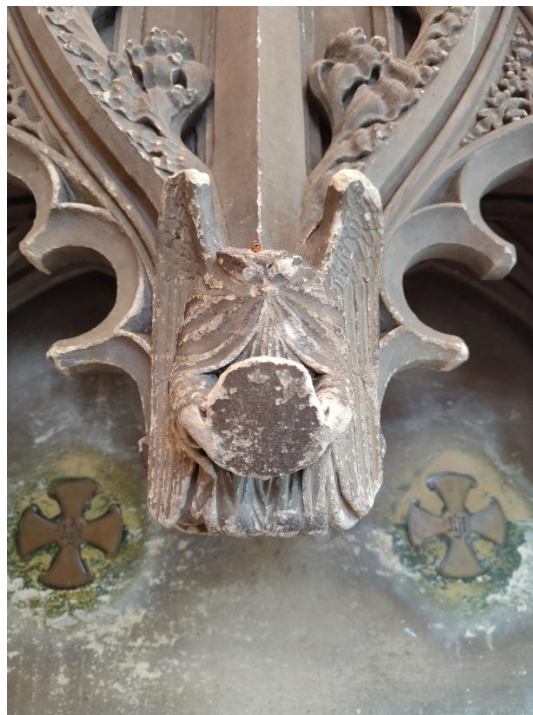
*Figure 35 show the iron dowel used to support the angel head with active oxidation.*

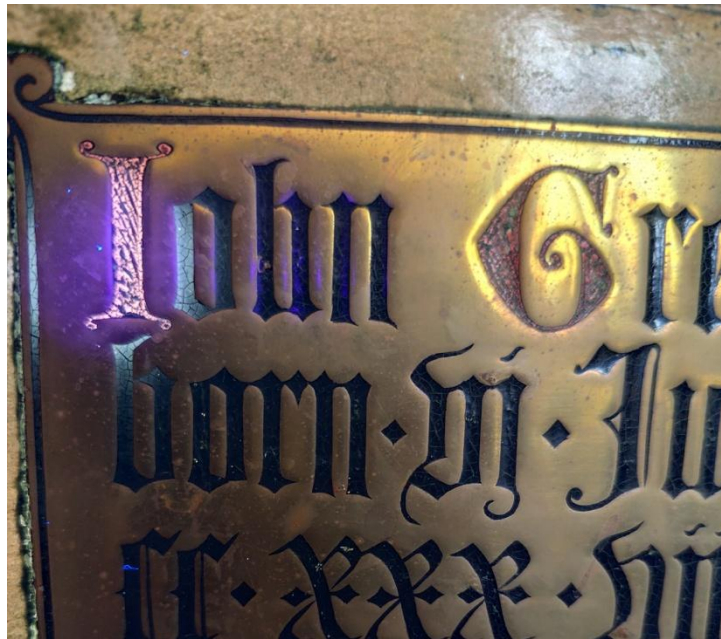
There is also evidence of polychromies, blue and red paint applied to the brass inscriptions, which is now degraded and partially visible.

*Figure 36 UV light shows the red paint and black paint applied to the lettering, and diffuse cracking.*

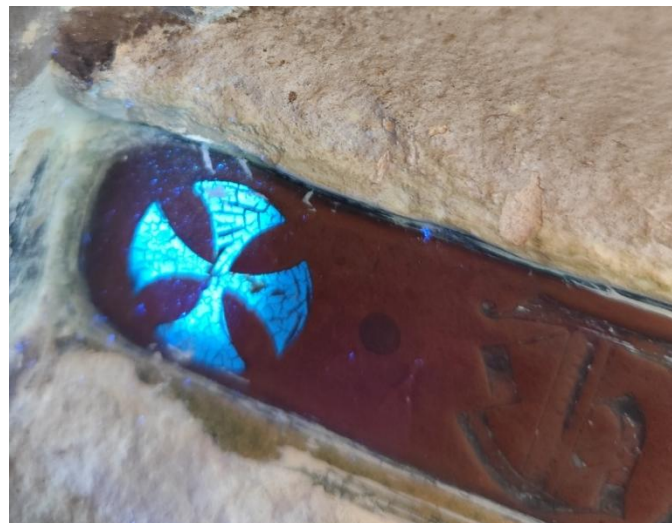
*Figure 37 show the diffuse cracking of the paint film and paint fluorescence.*

Finally, there are signs of a past cleaning attempt to the brass element, which abraded the stonework and caused damage to the paint film.
