## **PROPOSED REDEVELOPMENT OF St. ANDREWS CHURCH, KEIGHLEY STRUCTURAL SUMMARY REPORT**

**St. Andrews Church,  
Keighley,  
BD21 5HT**

**Prepared for:- Church on the Green Neighbourhood  
Foundation**

| Date | 18 <sup>th</sup> June 2025 |

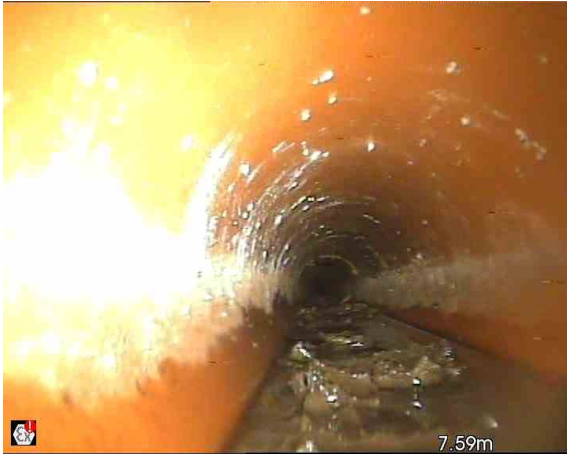
HOLX\_9d12f336-8dd5-4552-a565-83569e797c79\_20241204\_093454\_644.jpg, 00:00:27, 7.40 m  
Settled deposits, coarse, 10% cross-sectional area loss, start

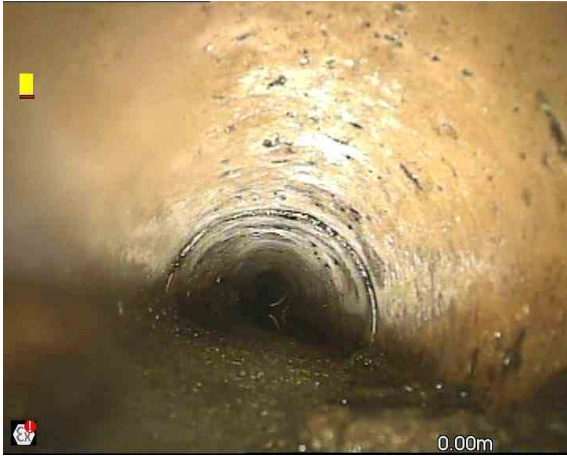
HOLX\_f5b15a02-15c6-49ca-ad68-5e1ce1ecfc98\_20241204\_093814\_295.jpg, 00:00:03, 0.00 m  
Settled deposits, fine, 25% cross-sectional area loss, start

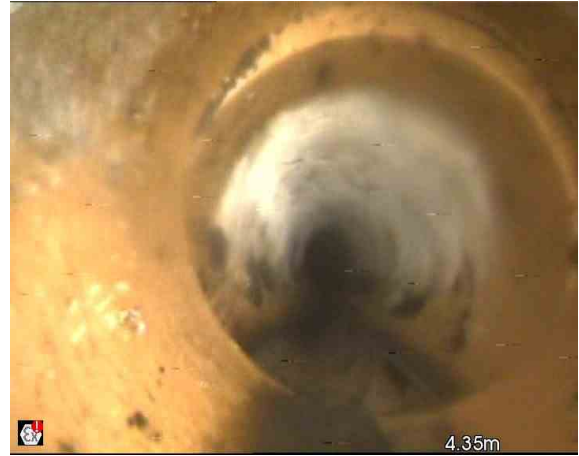
HOLX\_8fe7d4a0-a447-4f32-8652-4e34f0c8edb9\_20241204\_094802\_729.jpg, 00:00:22, 4.50 m  
Joint displaced, large

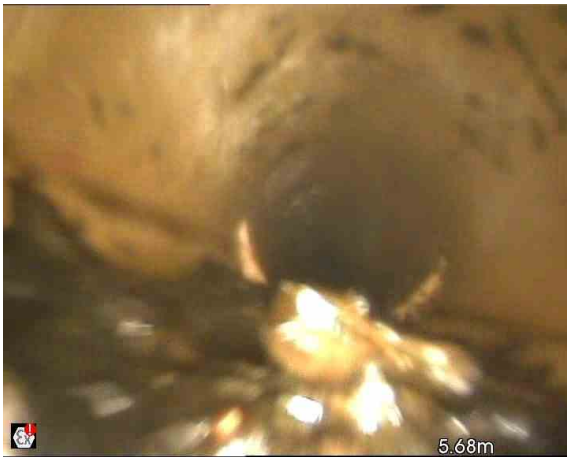
HOLX\_de0a0591-9f40-4000-95a9-1d120054087b\_20241204\_094912\_845.jpg, 00:00:25, 6.00 m  
Joint displaced, large

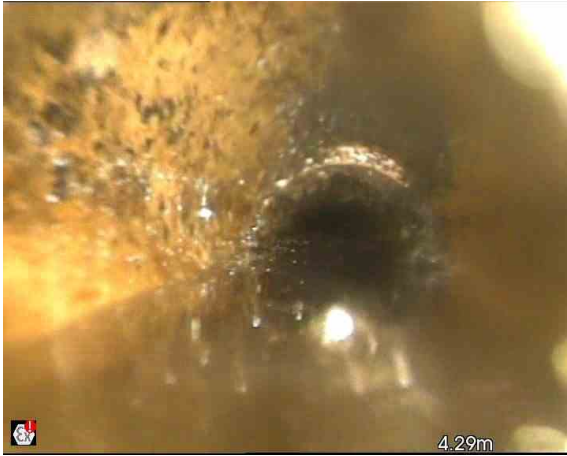
MH3X\_03bf998c-1b52-4fa0-91a1-7b8871073471\_20241204\_095750\_087.jpg, 00:00:19, 4.40 m  
Water level, 40% of the vertical dimension

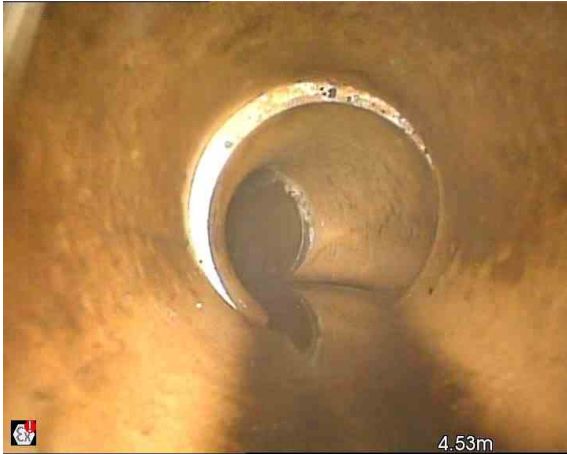
MH4X\_25a2e17d-f70c-44fa-9597-381f4a33c61e\_20241204\_1  
00732\_816.jpg, 00:00:25, 4.80 m  
Joint displaced, medium

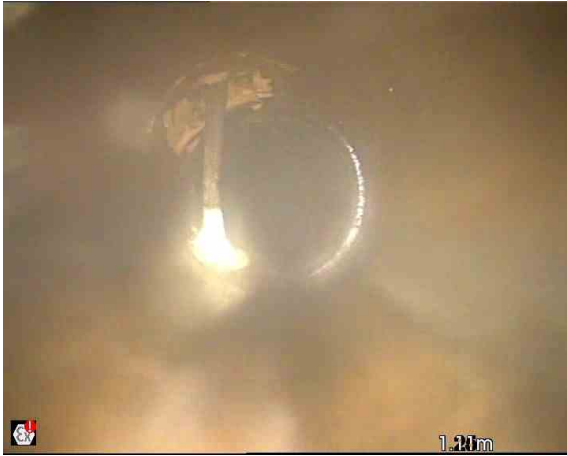
MH5X\_9fc6e4c7-2a43-4a5b-87c7-f4a1d26bb878\_20241204\_101328\_412.jpg, 00:00:07, 1.80 m  
Broken pipe from 10 o'clock to 12 o'clock

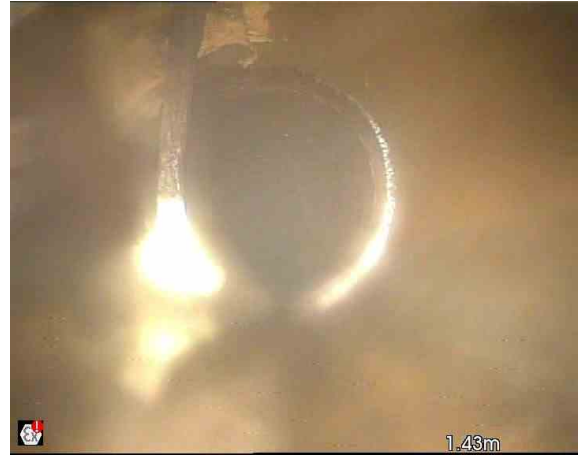
MH5X\_c0c3a63c-6cdc-4a35-a548-ab103acfaab9\_20241204\_101307\_004.jpg, 00:00:08, 1.80 m  
Other obstacles from 7 o'clock to 11 o'clock, 10% cross-sectional area loss, through pipe wall

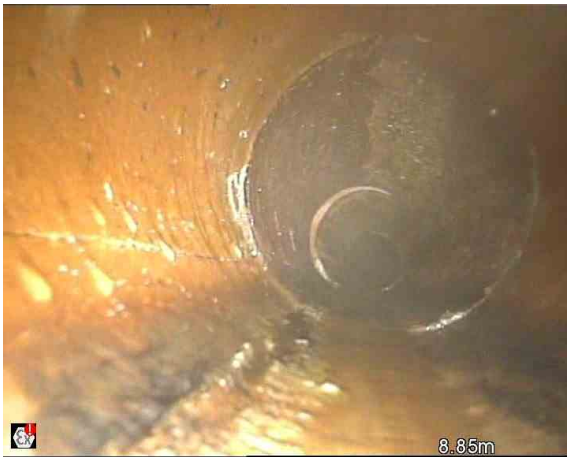
MH5X\_185be66f-17c8-4d9e-bd18-b977a3fbfb20\_20241204\_101449\_021.jpg, 00:00:52, 8.70 m  
Crack, longitudinal at 8 o'clock, start

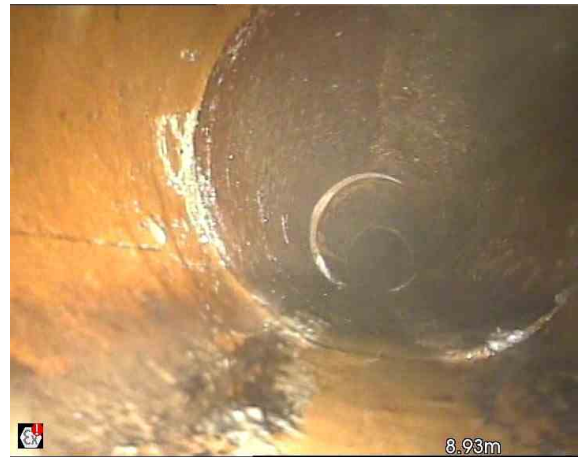
MH5X\_6a26c413-ea11-457a-957f-f760f4e0470e\_20241204\_101453\_766.jpg, 00:00:52, 8.70 m  
Crack, longitudinal at 8 o'clock, start

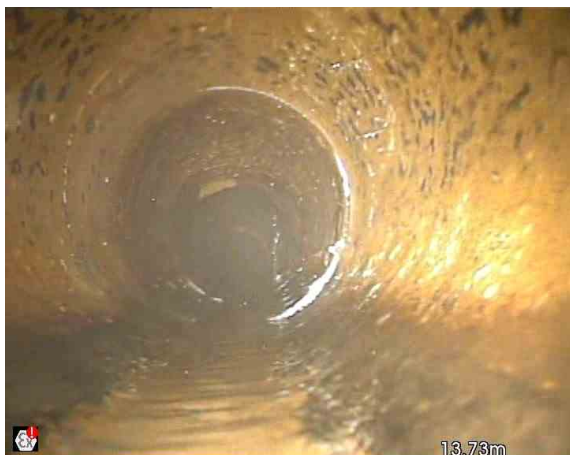
MH5X\_d408e408-6f02-4475-9b5c-a995a6e660a8\_20241204\_111046\_661.jpg, 00:01:17, 14.00 m  
Crack, circumferential from 7 o'clock to 3 o'clock

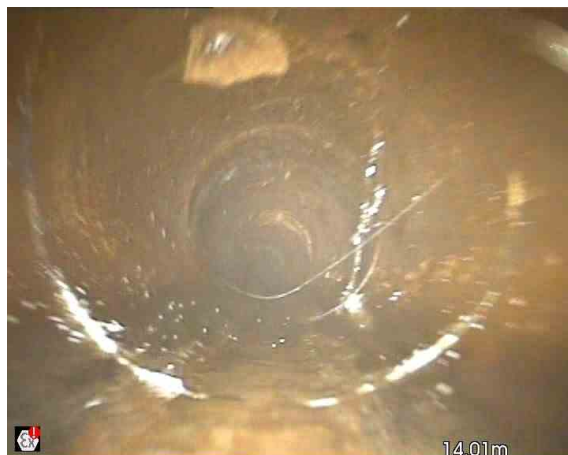
MH5X\_175cf094-4b0a-4ec2-a684-b70b6543e0f9\_20241204\_111100\_422.jpg, 00:01:18, 14.30 m  
Hole in drain or sewer at 11 o'clock

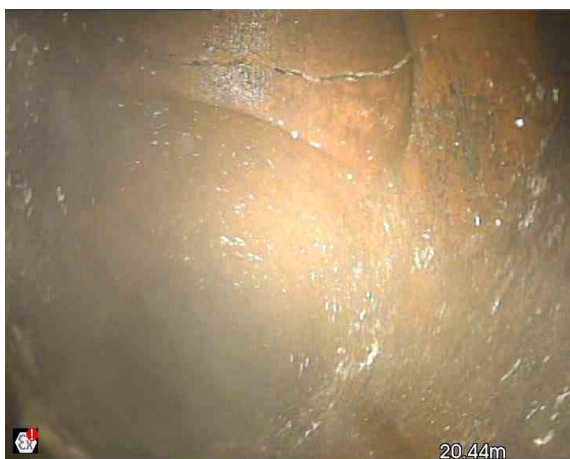
MH5X\_abe27e89-56a8-431a-99ec-3d3ba66a8485\_20241204\_111530\_717.jpg, 00:01:44, 20.60 m  
Fracture, circumferential from 10 o'clock to 2 o'clock, inside connection

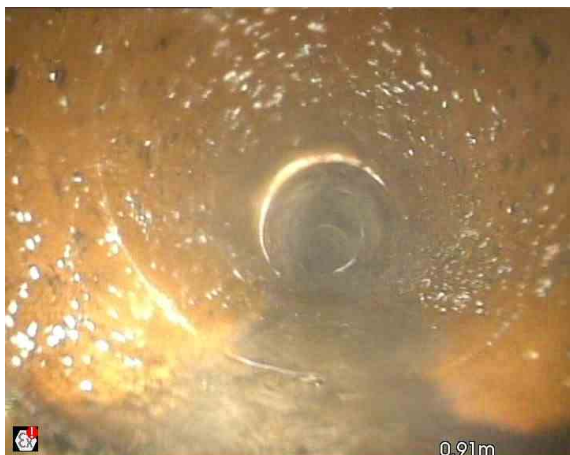
HOLX\_b8521a0e-a45a-4bdd-8b27-920ac559ada8\_20241204\_115742\_254.jpg, 00:00:11, 1.00 m  
Crack, circumferential from 12 o'clock to 12 o'clock

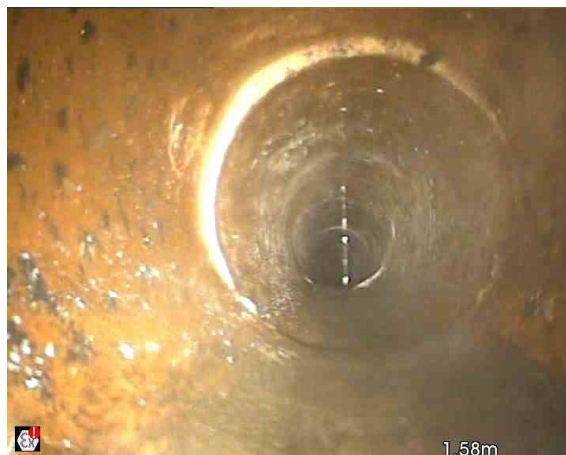
HOLX\_8403c2cd-9572-4d5d-a5bb-ef0710bb80ff\_20241204\_115838\_850.jpg, 00:00:12, 1.80 m  
Joint displaced, medium

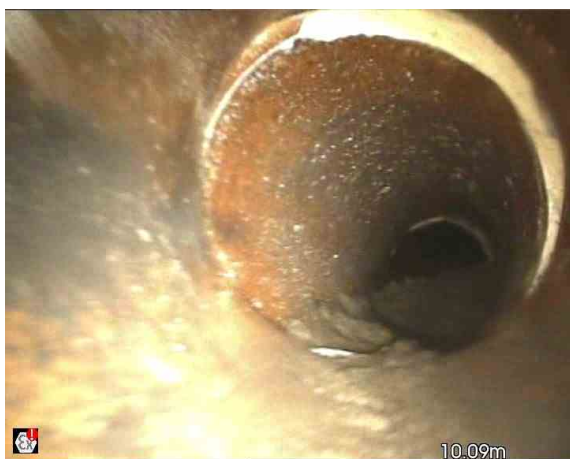
HOLX\_b332ada4-07d8-4aa5-a926-19bf2996e49c\_20241204\_115919\_896.jpg, 00:00:33, 10.30 m  
Joint displaced, large

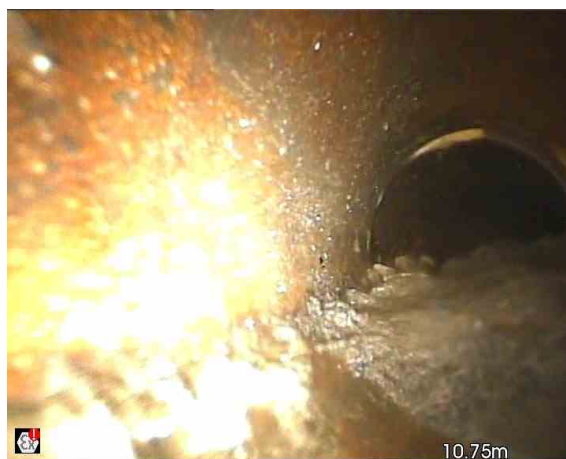
HOLX\_6fb0ee1b-c051-431e-b61d-a9be6db5d8c1\_20241204\_115941\_937.jpg, 00:00:35, 10.90 m  
Settled deposits, coarse, 40% cross-sectional area loss, start

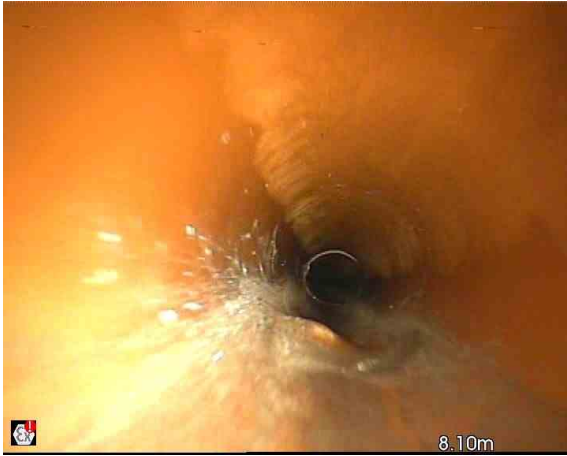
HOLX\_3cf57756-9adf-4abe-92db-7a30f6c4a8a6\_20241204\_1  
20731\_002.jpg, 00:00:20, 8.30 m  
Deformed sewer or drain, 5%, 06 to 07 o'clock

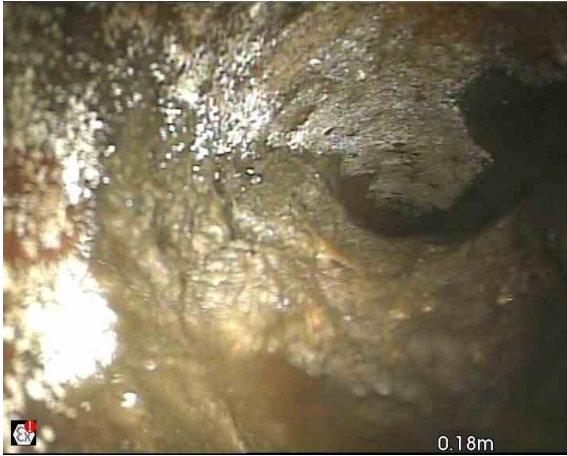
HOLX\_cb390839-b95b-4231-8f0f-a8d9737cf4ed\_20241204\_1  
23249\_462.jpg, 00:00:06, 0.30 m  
Settled deposits, coarse, 50% cross-sectional area loss, start

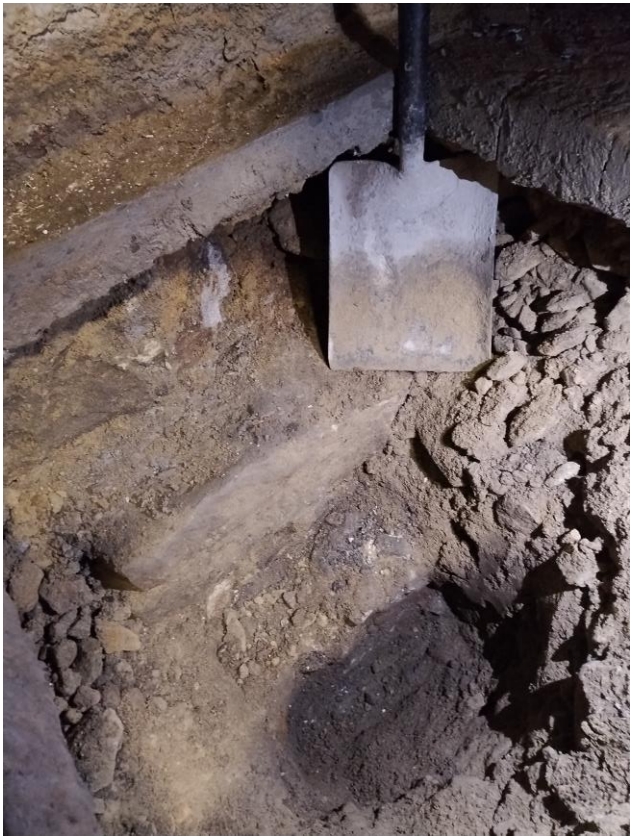
- 3.12 The excavation uncovered an existing widening of a foundation stone bearing onto a formed foundation of large aggregate bound together with a type of lime mortar mix. This foundation was again widened from the overall wall width, based on the visible wall width at ground floor level, the overall width of the foundation can be considered as approx. 1.590m wide with an approx. overall depth of 3.4m below ground floor level. The formation level was seen to be on natural ground, namely sedimentary materials of sand and gravel in 'medium-dense' to 'dense' consistency, which matched the description of the material as described within the ground investigation of Alluvial Fan Deposits. This material will have been deposited following glacial movement following the Ice Age. This level, below the external ground level, is evidence of the level of the natural ground, namely sedimentary material (Alluvial Fan Deposits), as referred to within the ground investigation report from the dynamic probing and local borehole records.

Photo 1 – General view on trial hole showing excavation and outstand of stone footing and lime mortar mix concrete.
