# **Ground Investigation Report** [intrusive]

St Andrew's Church, Keighley

| Project Number | 20442 |
| Date Issued | 16 December 2024 (V01) |

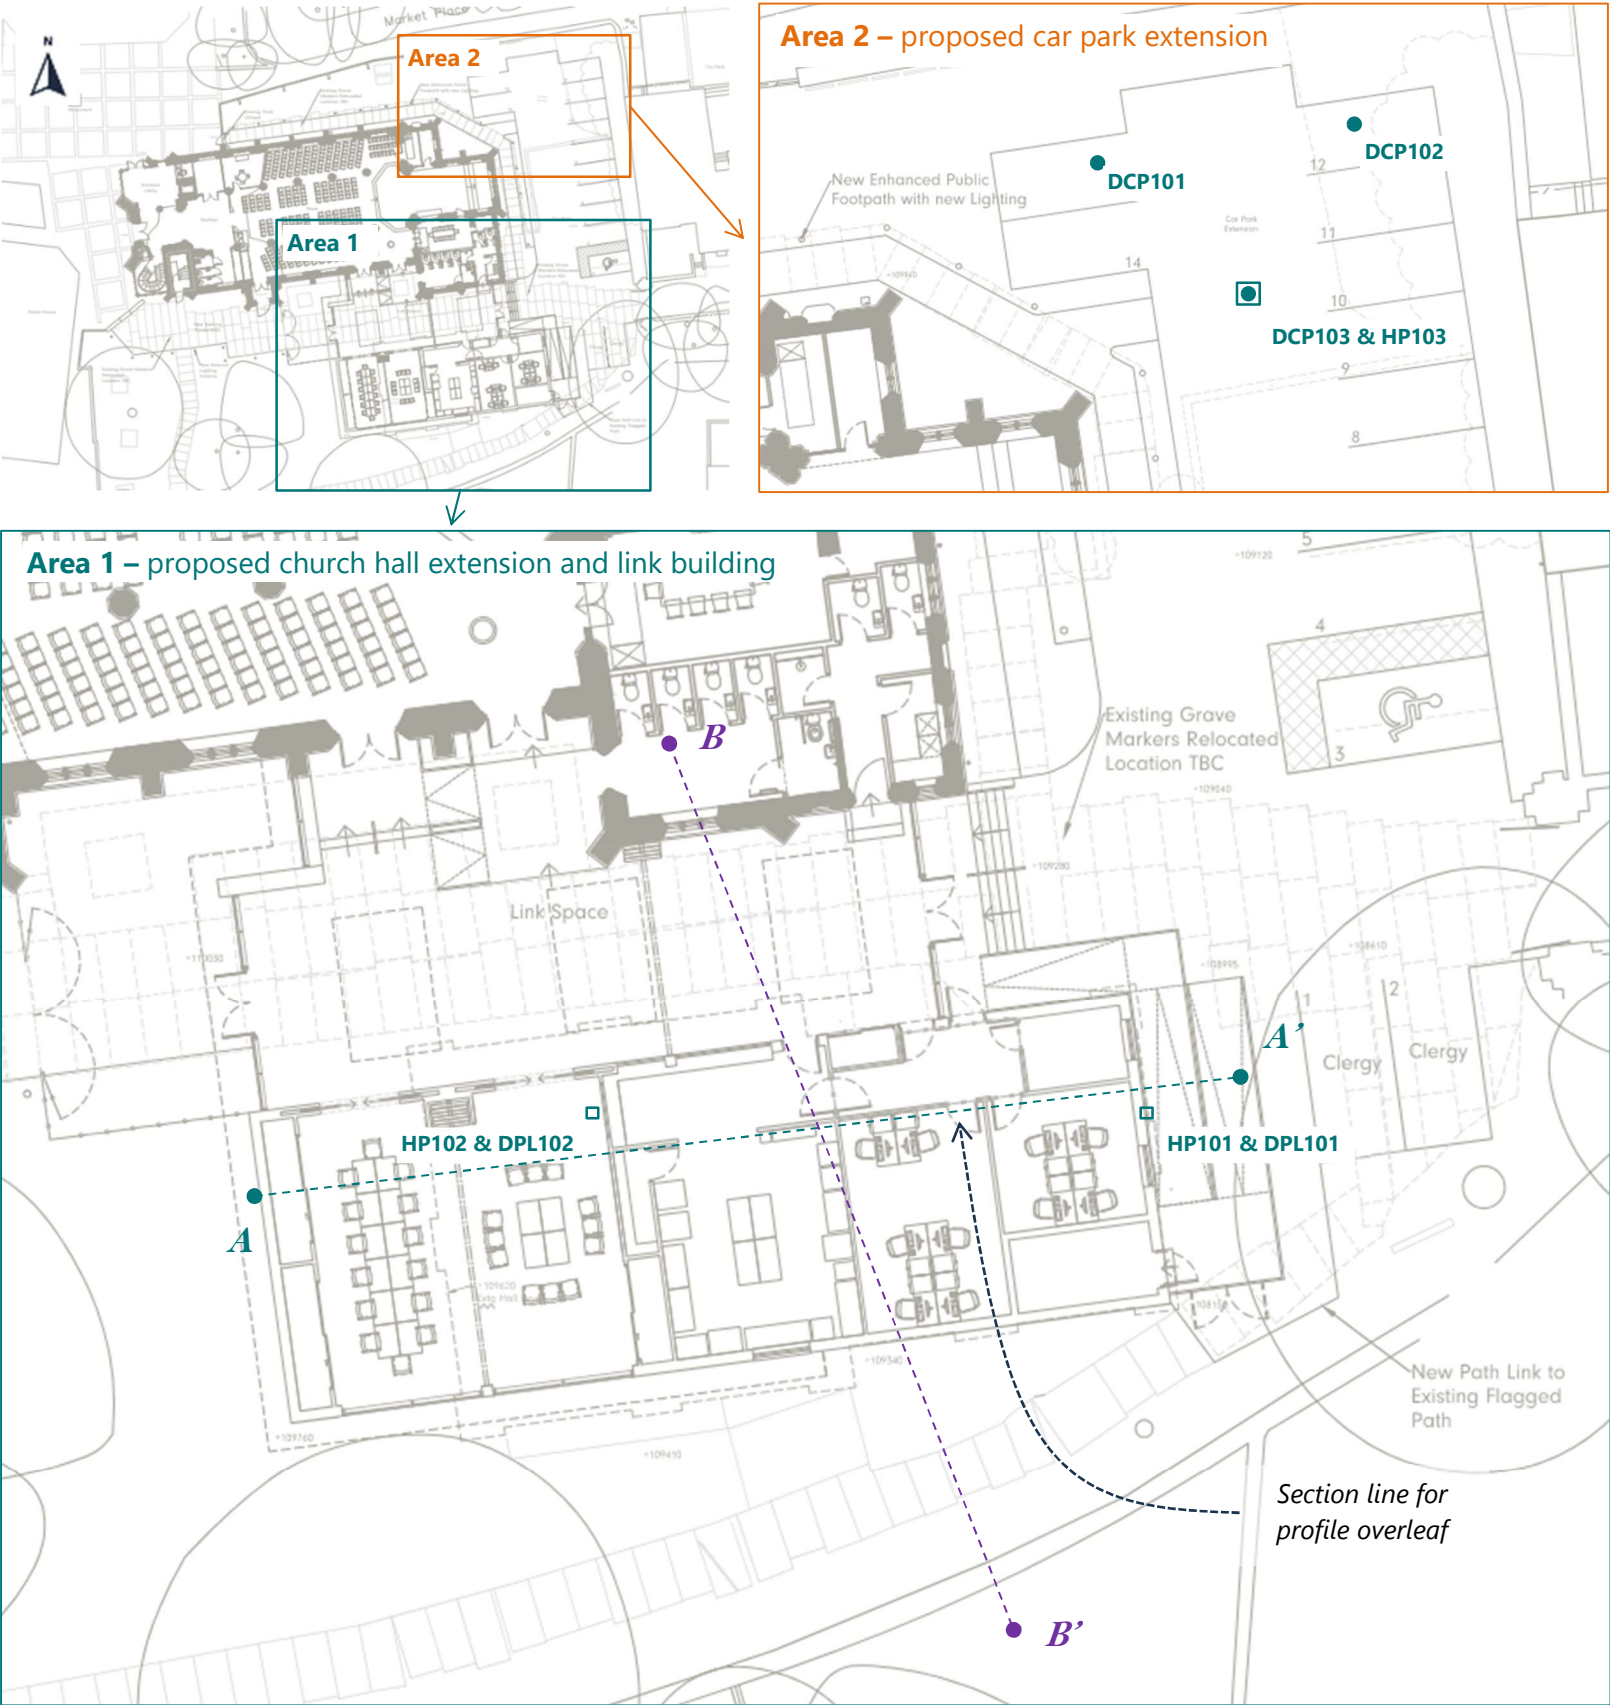
5.0 Ground Model – Plan

- > **Surface cover** across both areas comprised a thin Topsoil cover (with paving slabs noted in HP102)
- > **Made Ground** deposits were encountered within all exploratory hole locations.  
Across Area 1 (proposed church hall extension and link building) these deposits comprised construction materials associated with the church hall’s original construction and were proven to a depth of 1.20 m below ground level.  
Across Area 2 (proposed car park extension) these deposits comprised ‘ash fill’ over ‘sandstone fil’ that likely relates to the original church’s construction.

- > Apart from roots relating to former trees within HP103, no evidence of **degradable material** was encountered within the exploratory holes.

Based on the revealed ground conditions, ground-related hazards identified that could influence the proposed development all relate to the presence of the Made Ground deposits with the depth and inherent variability/instability of these soils informing design decisions.  
Please refer to Section 6.0 for further commentary and advice.

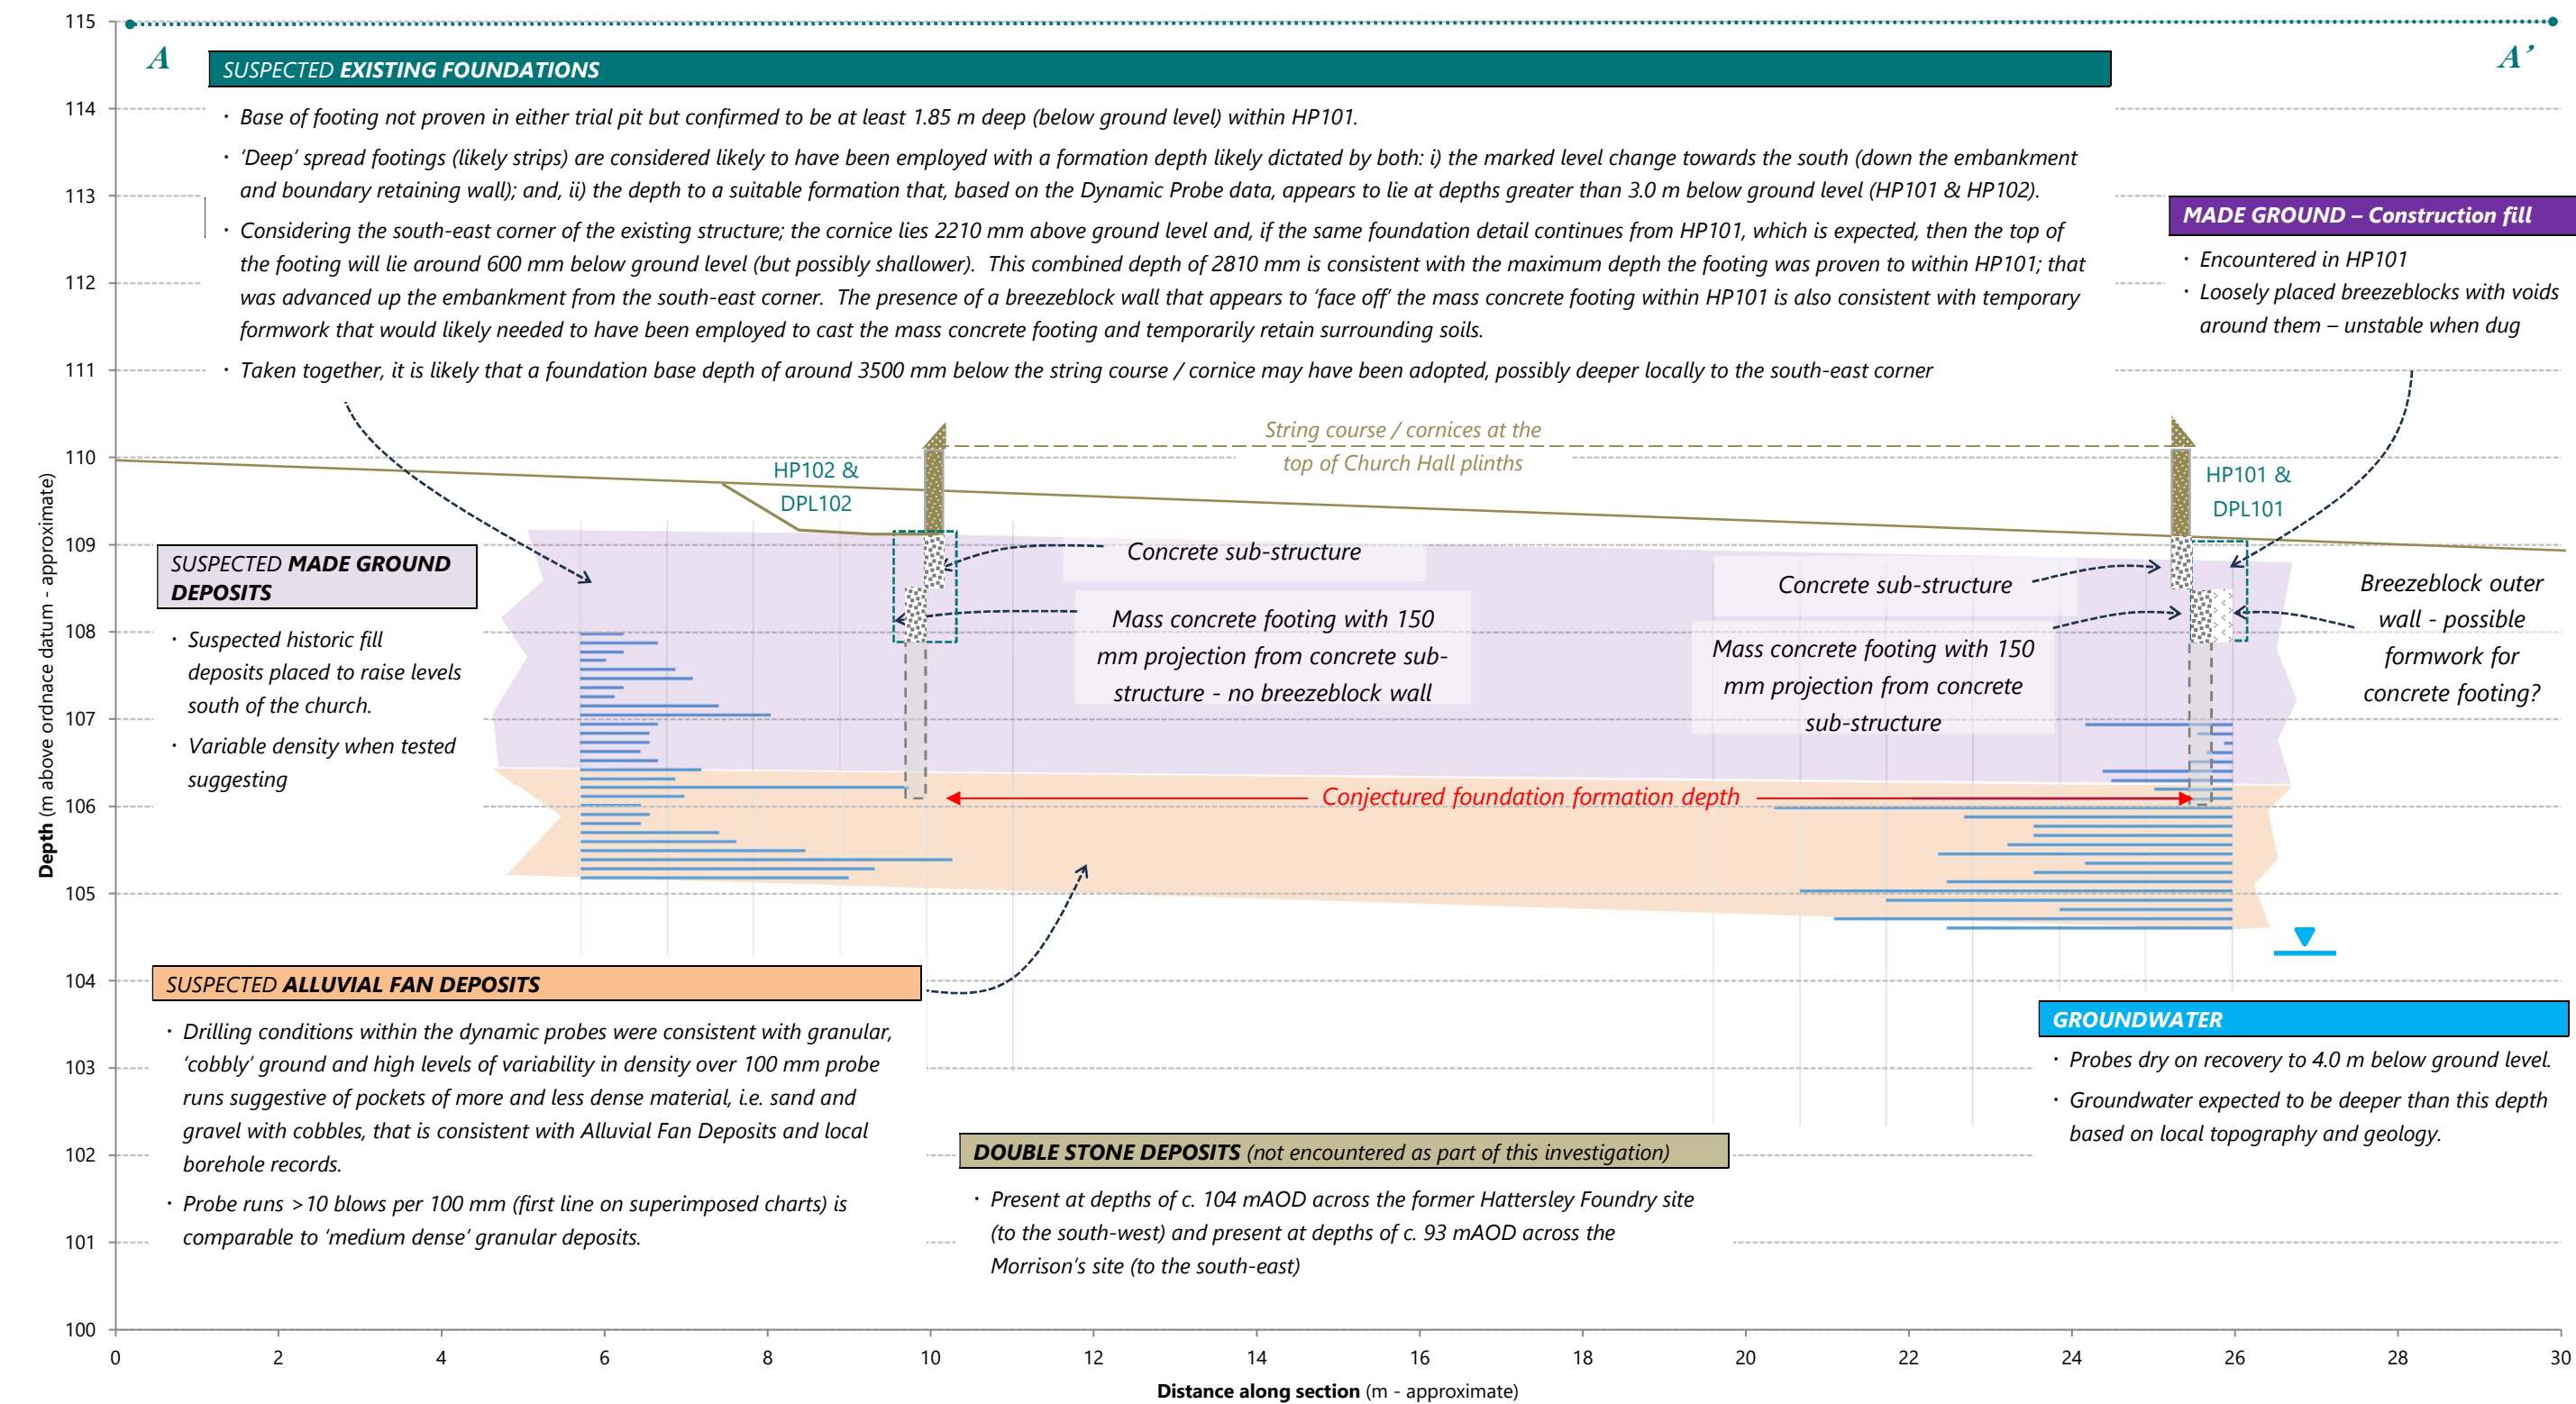
5.0 Ground Model – Profile

- > Ground conditions are consistent with those anticipated with an apparent ‘wedge’ of Made Ground deposits beneath the existing church hall structure a defining feature of the ground conditions on this Site.
- > Further investigation is not recommended but may be required to refine pile design parameters or subject to any design changes or requests from appointed contractors.
- > Risk mitigation is not recommended to address ground-related hazards to acceptably low levels however, general advice with respect to ground engineering risk management and design considerations is presented throughout Section 6.0 of this Report.

The use of a **piled foundation solution** is recommended in this scenario guided by:

- > For preliminary design purposes, bedrock (target depth for piles) could be taken as depths of between 93 to 104 mAOD that, with reference to the ground level across the church hall, would result in maximum pile lengths of around 16 m. It is noted that bedrock was present within 3 m of ground level across the former Hattersley Foundry site to the south-west that, relative to the Site, would translate to pile lengths of between 5 and 6 m.
