**Report Reference No: PEL-00103**

St Andrews  
Church Building:  
Church Street, Keighley BD21 5HT /  
Hall:  
Market Street, Keighley, BD21 5AD

## **Asbestos Refurbishment Survey Report**

**Date 06/12/2024**

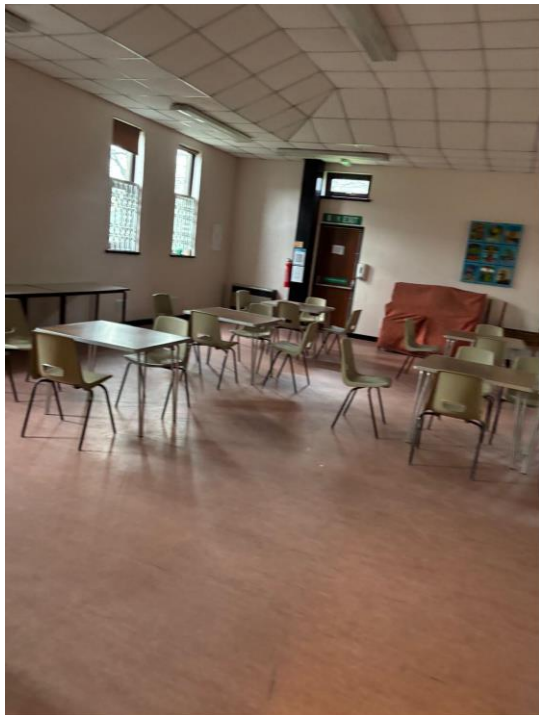
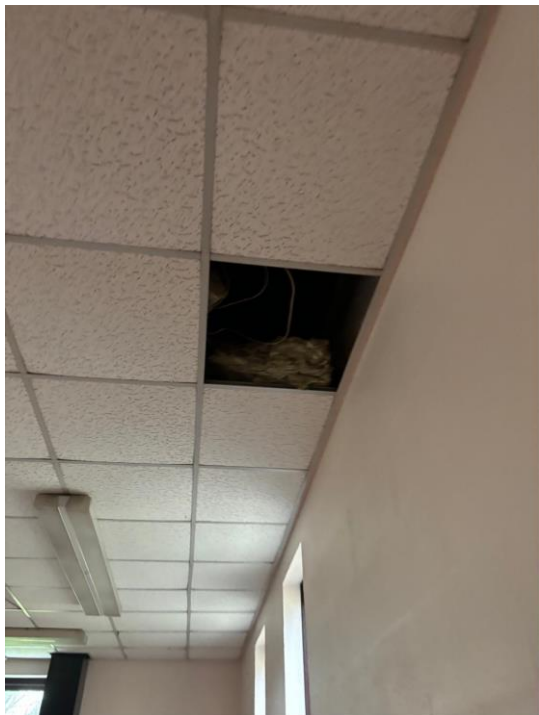
| Location: | Church Hall | | |

| Item: | Walls / Ceiling / Floor | | |
| Approx. Extent: | N/A | Score: | |
| Product Type: | N/A | 0 | |
| Condition: | N/A | 0 | |
| Identification Method: | Visual | | |

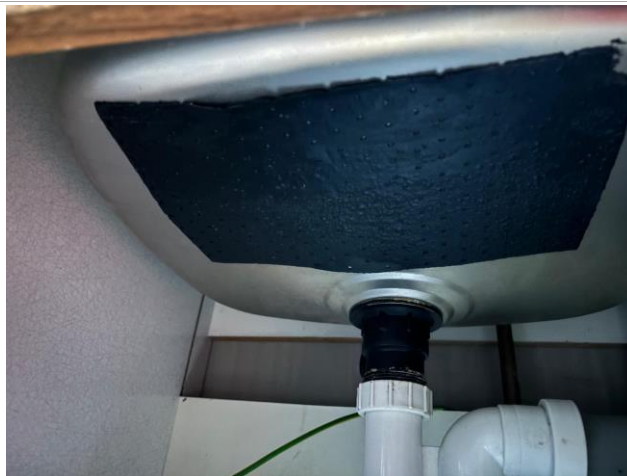
| Survey Sample Ref | Zone Level | Room/ Location | Element | Material Condition | Material Access | Material Extent Approx. | Cert. No/ Analytical Result | Material Assessment | Material & Type | Priority Assessment |
|---|---|---|---|---|---|---|---|---|---|---|
| PEL-10 | Ground | Kitchen | Sink Pad | Fair | E | XI | Sampled 001 | 4 | Bitumen | N/A |

| <b>Condition:</b> | Good | | 1 |

| <b>Action:</b> | Remove ACMs in accordance with the 2012 Asbestos Regulations by a competent / trained contractor. | | |

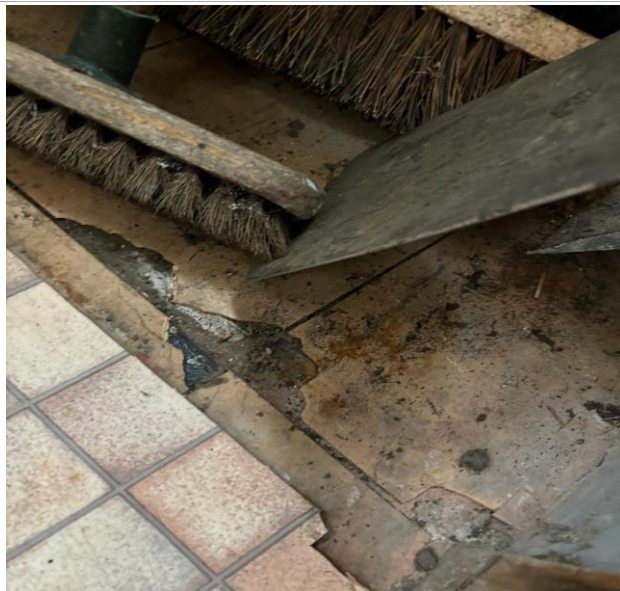
| <b>Survey ID</b> | PEL-15 | | |

| Survey Sample Ref | Zone Level | Room/ Location | Element | Material Condition | Material Access | Material Extent Approx. | Cert. No/ Analytical Result | Material Assessment | Material & Type | Priority Assessment |
|---|---|---|---|---|---|---|---|---|---|---|
| PEL-15 | Ground | Kitchen Cupboard | Floor tiles | Fair | E | 2m2 | Sampled 004 | 4 | Bitumen | N/A |

| <b>Location:</b> | Kitchen Cupboard | | |
| <b>Condition:</b> | Good | | 1 |

| <b>Action:</b> | Remove ACMs in accordance with the 2012 Asbestos Regulations by a competent / trained contractor. | | |

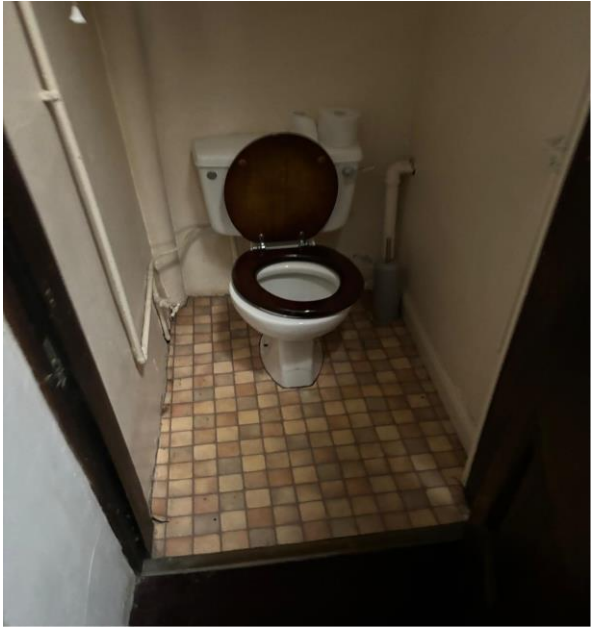
| <b>Survey ID</b> | PEL-16 | | |

| Survey Sample Ref | Zone Level | Room/ Location | Element | Material Condition | Material Access | Material Extent Approx. | Cert. No/ Analytical Result | Material Assessment | Material & Type | Priority Assessment |
|---|---|---|---|---|---|---|---|---|---|---|
| PEL-16 | Ground | W/C | Floor tiles & Adhesive | Fair | E | 2m2 | Sampled 005 | 4 | Bitumen | N/A |

| <b>Location:</b> | W/C | | |
| <b>Item:</b> | Floor Tile and Adhesive | | |
| <b>Approx. Extent:</b> | 2m2 | <b>Score:</b> | |
| <b>Product Type:</b> | Bitumen | I | |
| <b>Condition:</b> | Good | I | |
