St Andrew's Church, Church Street, Keighley, BD21 5HT

Historic Building Recording

| Project Ref: | BWH2526-64 |
| Document Ref: | Report No. 2526-64A |

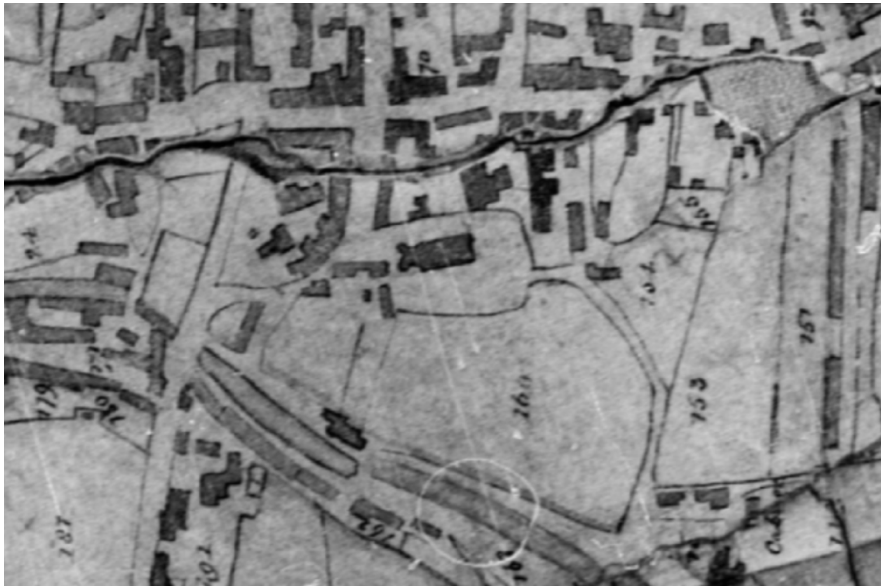
Figure 3 1840 Tithe Map of the Parish of Keighley in the County of York

The medieval church was demolished in 1805 and replaced by a larger building. This new structure featured a substantial porch and was set within open land, as recorded on the 1840 tithe map. The building was itself demolished in 1843, following identification of significant structural failings, and the site was prepared for a further rebuilding.

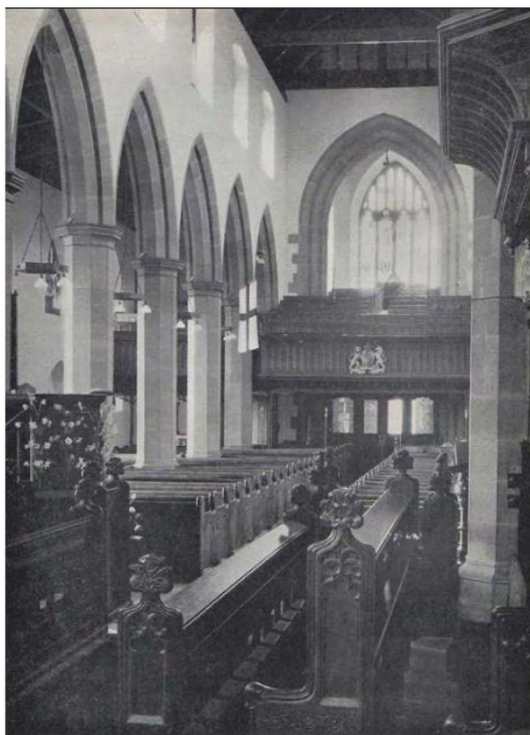
Figure 6 Photograph from 1948 showing the side galleries following removal, and the rear gallery as it appears today. It is understood that the original pews in the nave were removed in the 1970's and 1980's (taken from the Heritage Statement prepared by RJW Design Studio, 2025)

As previously noted, the gallery may be accessed via either the south or north stair. The gallery is of timber construction. Historically, the gallery extended above the side aisles; however, these side galleries were removed in 1931. Consequently, the surviving sections of the gallery adjacent to the side aisles were substantially altered to create their present configuration. One section of the original front balustrade from each side gallery has been retained and reused to form the current side balustrades, albeit with modifications to accommodate the revised layout.

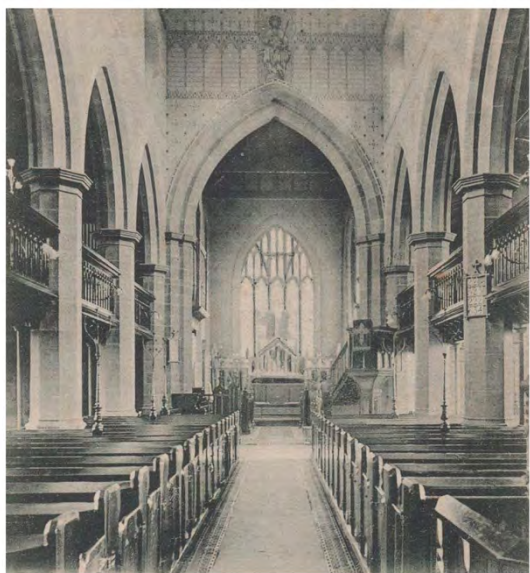
Figure 7 Photograph from 1948 showing the original side galleries (taken from the Heritage Statement prepared by RJW Design Studio, 2025)

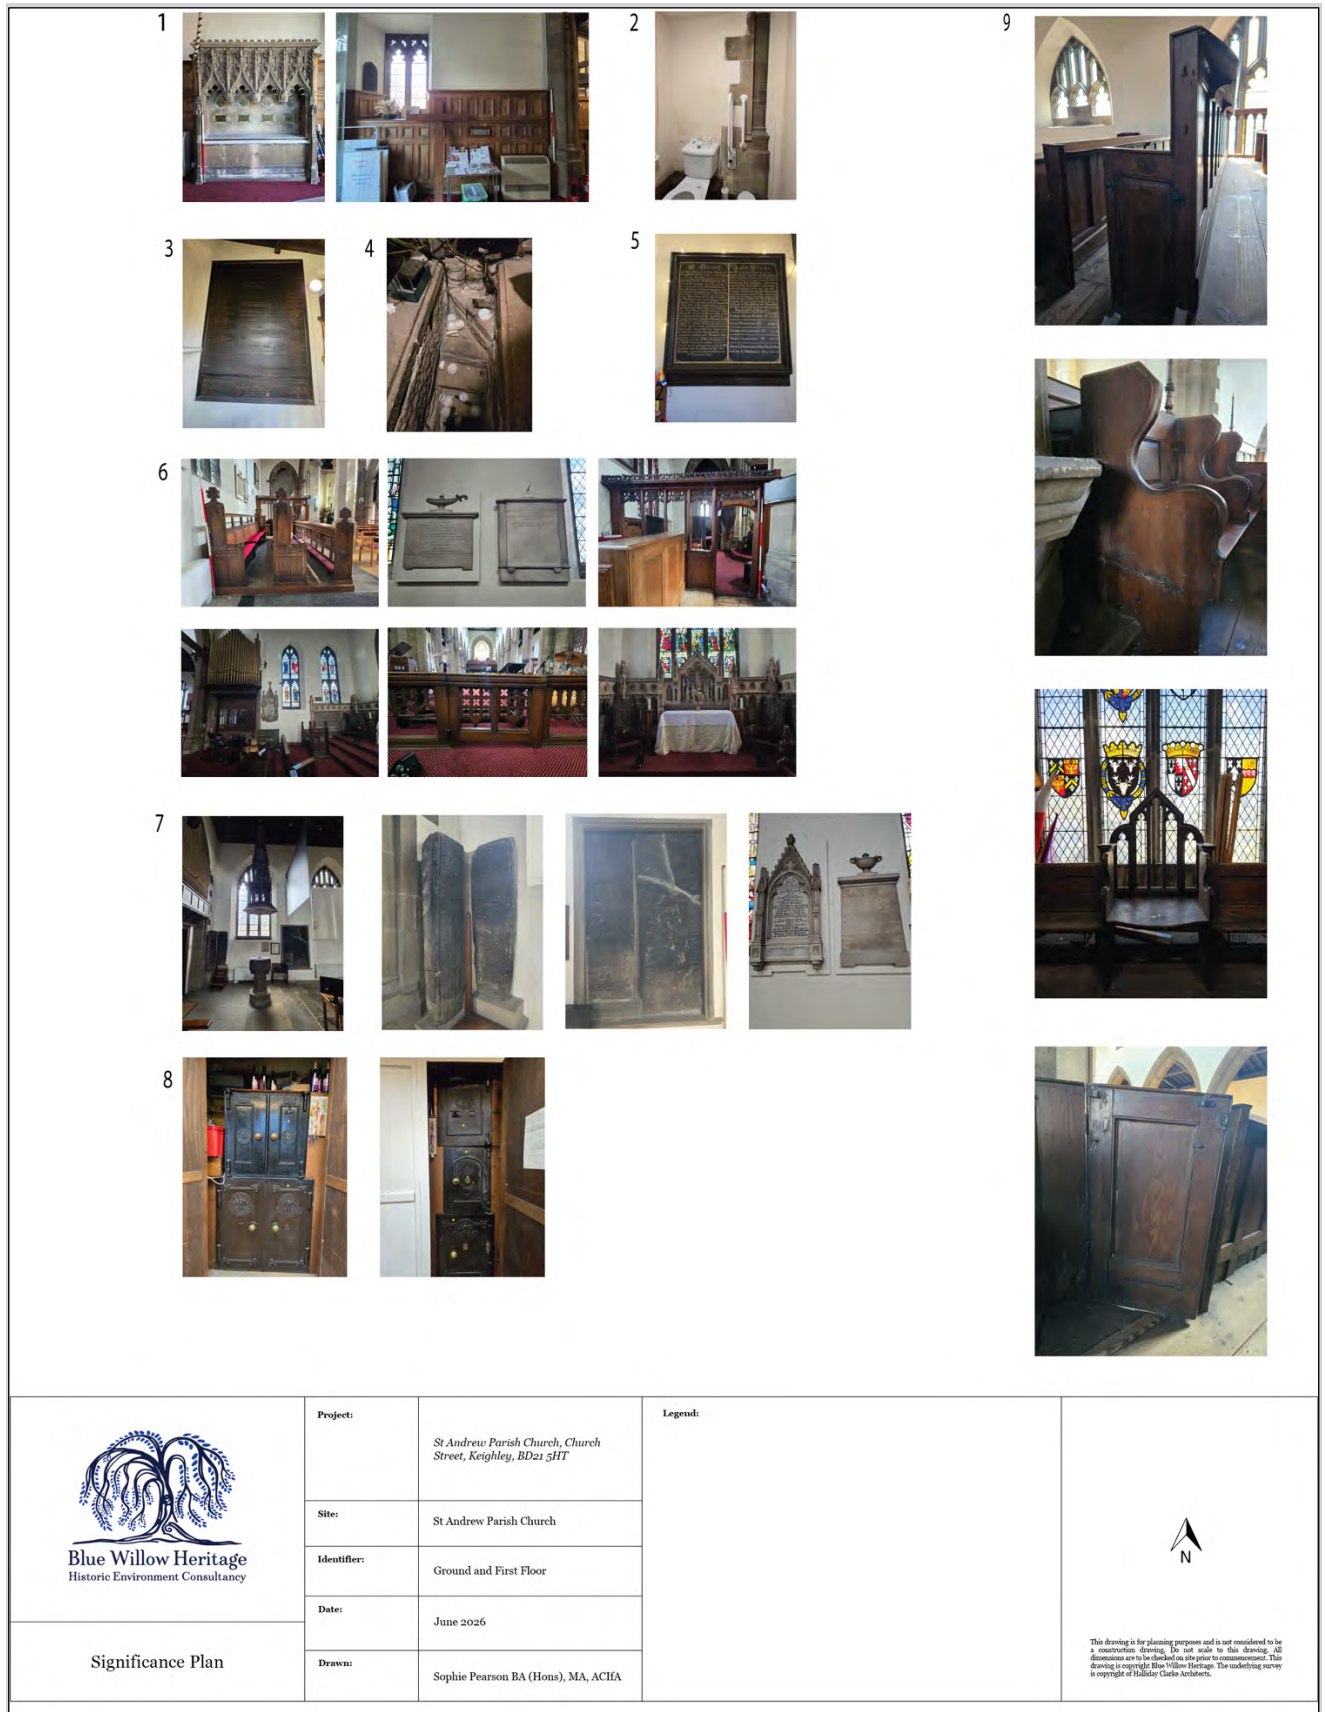
Figure 13 Main Church Significance Plan (Ground Floor and First Floor)
