# St Andrews Church, Keighley: Monuments Condition Assessment and Relocation Methodology

Author: Valerio Caputi, MA, Head Conservator for Pinnacle Conservation Ltd  
Lev 7 Cultural Heritage Conservator, Icon Pathway Member

Date of inspection: 10/02/2026

Property address: 8 - 10 North Street, Keighley, BD21 3SE

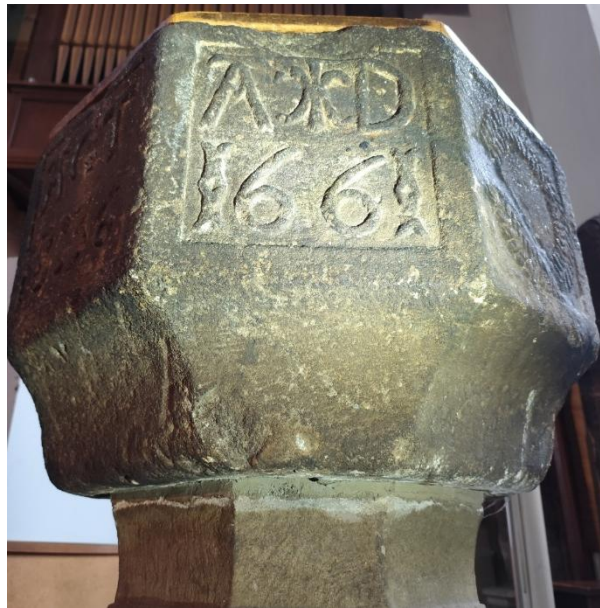
Figure 1 baptismal font showing panel with date.

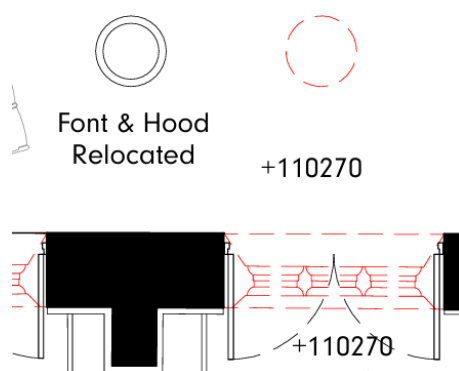
Figure 12 show part of the plan related to the font.

This will require removing and refixing the object, which presents risks of damage and loss.

It is recommended that the font is protected with a timber boxing during the building work, and its condition before and after completion is well documented.

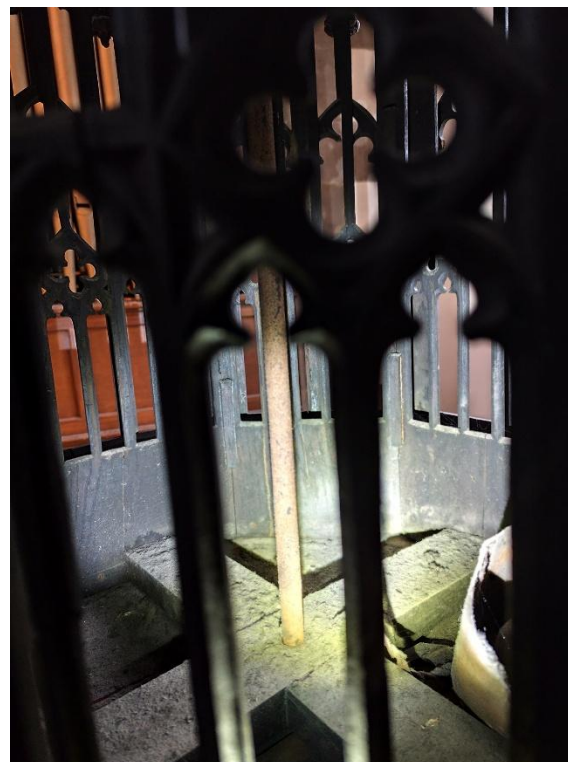
Figure 15 show the lower frame and the internal iron rod.

It appears to have been varnished, which is now oxidised and dark in colour.

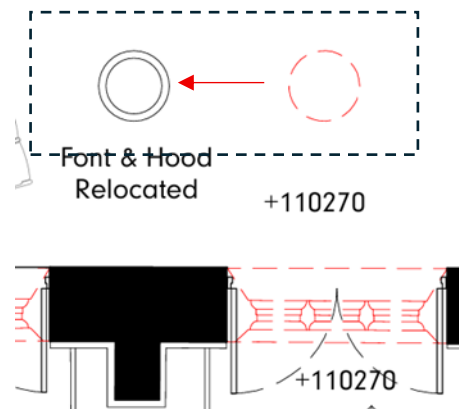
Figure 20 show required area of the scaffolding and its platform to aid removal and relocation of the font.

In order to safely and effectively control the lifting and re-location the use of a fixed scaffold is recommended. This will need to provide safe access to the upper section and hook, as well as offering a raised working platform with suitable handrails to move the object from the present to the suggested location.

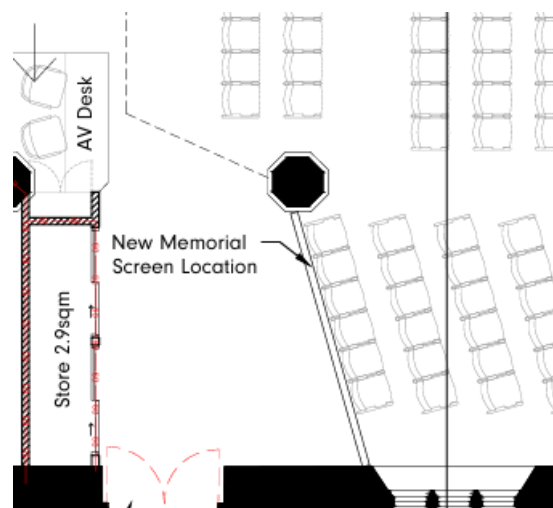
The Memorial could encounter mechanical damage during the relocation. On the other hand, it could benefit from the removal of the electric cable within the structure.

Figure 24 show the new proposed location.

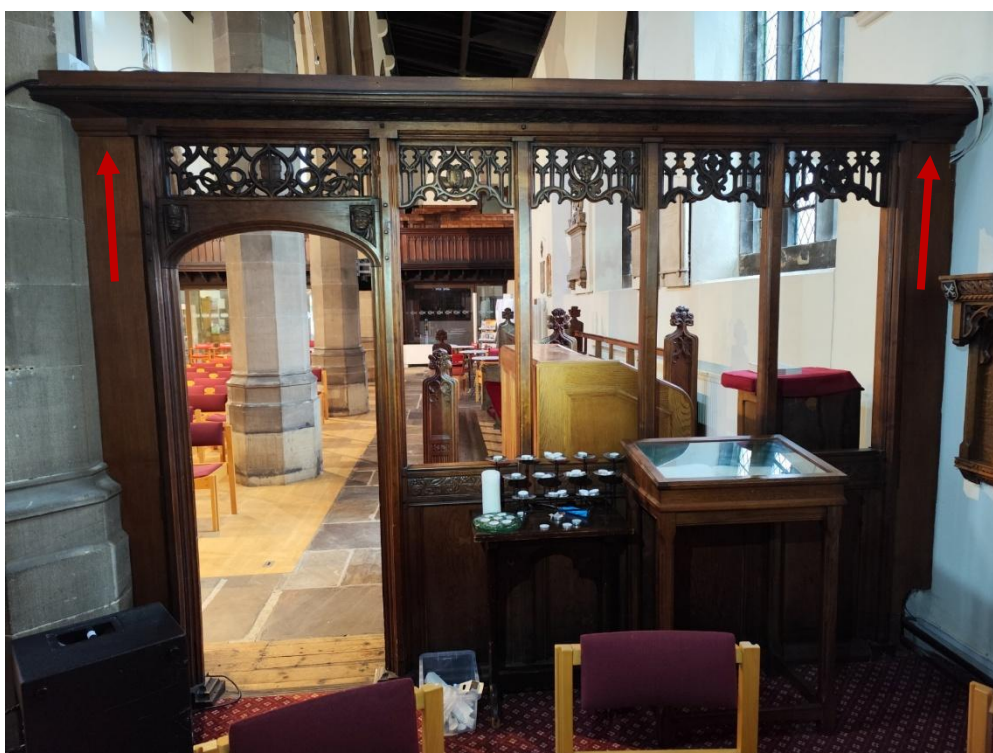
*Figure 25 show the suggested lifting points.*

The Memorial is composed of different structural elements connected with traditional joist and adhesive. To this structure, carved sections such as the tracery and carving were added and bonded with fine wooden dowels and animal-based adhesive. It is therefore suggested that the lift should be carried out by applying straps to the external section of the frame only. Where the light panels can be carefully removed.

The employment of a lifting frame is suggested, as well as a supporting movable platform. stabilise the structure during movement. Use of straps and or manual handling on the internal carved section could lead to structural damage and loss.

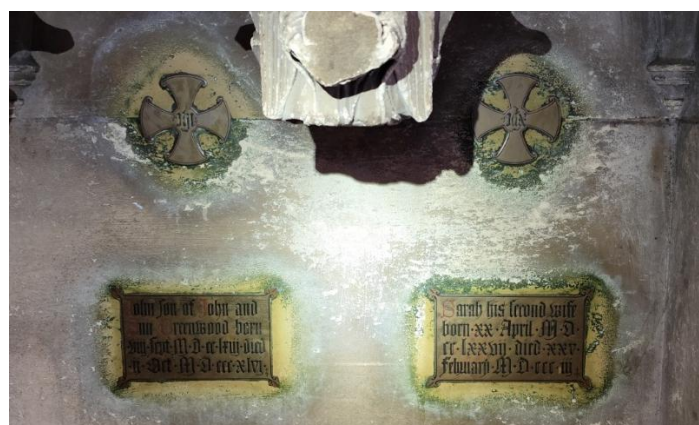
*Figure 32 show the brass plaques inserted in the stonework.*

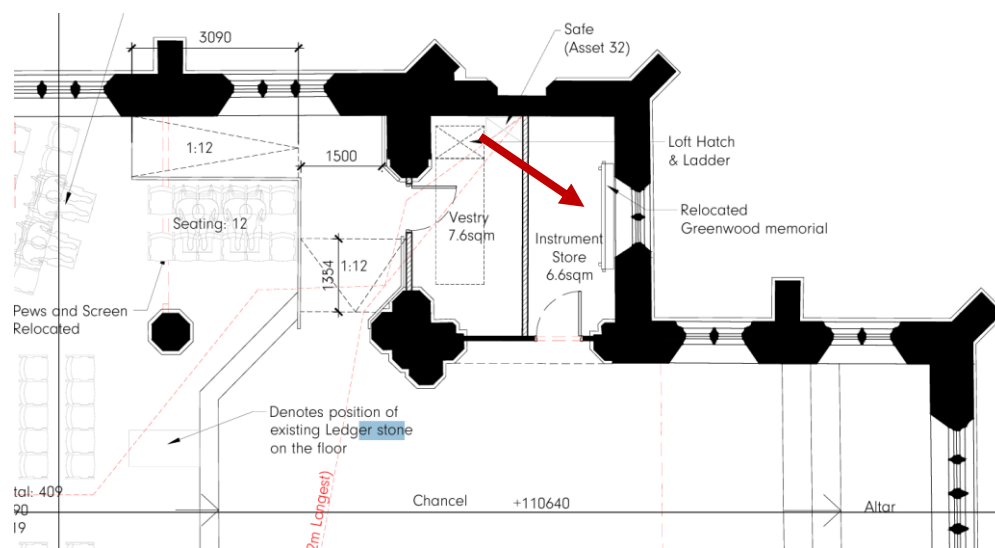
Figure 38 show proposed relocation of the Memorial

The relocation could offer opportunities if the Memorial is located in an area with a more stable environment and where public access is limited or more controlled, as this seems to be the case.
