## **PROPOSED REDEVELOPMENT OF St. ANDREWS CHURCH, KEIGHLEY STRUCTURAL SUMMARY REPORT**

**St. Andrews Church,  
Keighley,  
BD21 5HT**

**Prepared for:- Church on the Green Neighbourhood  
Foundation**

| Date | 18 <sup>th</sup> June 2025 |

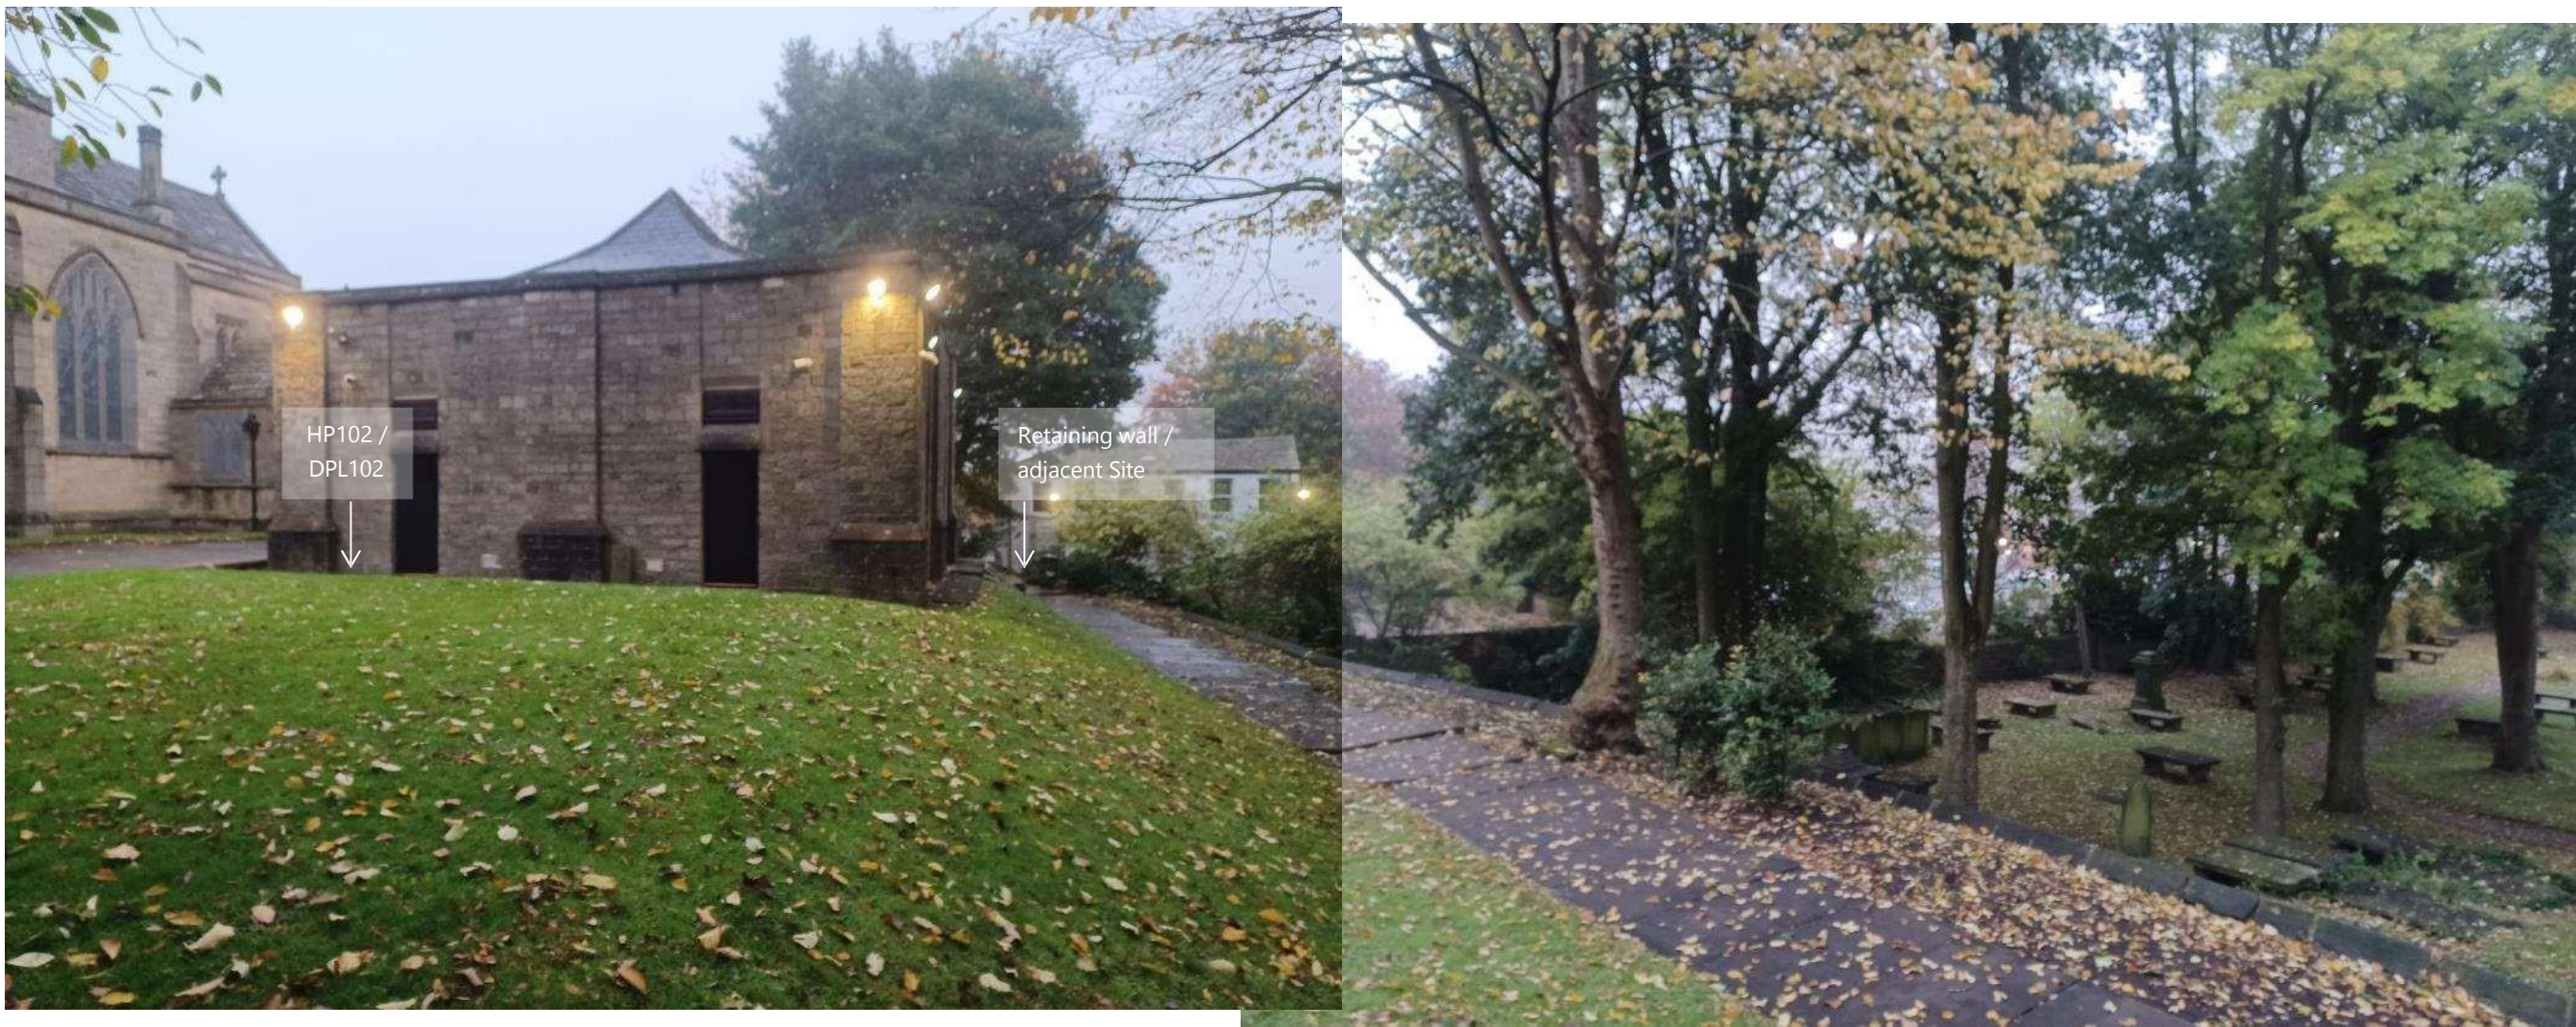
**Photograph 1:** Stitched panorama from the western portion of the Site looking east towards the existing church hall

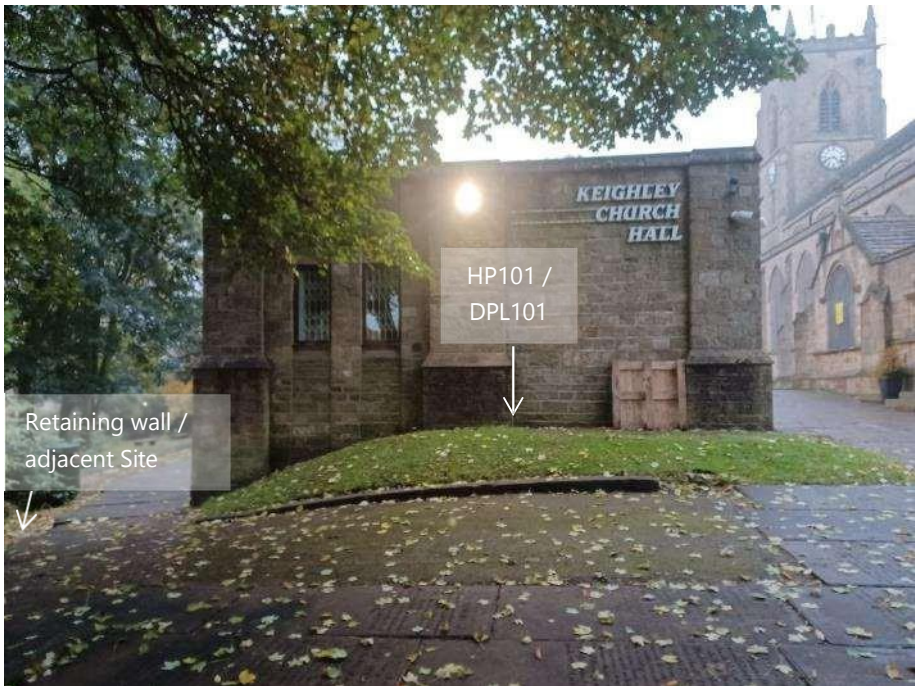
**Photograph 2:** View from the eastern portion of the Site looking west towards the existing church hall

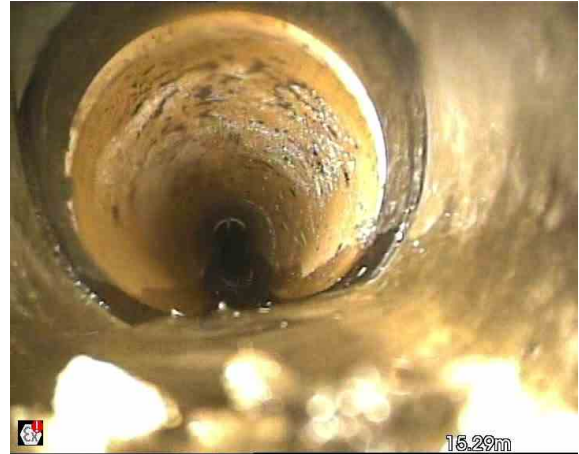
HOLX\_35a4a035-aa73-40cb-916c-0bc3d1fdb085\_20241204\_093653\_793.jpg, 00:00:52, 15.20 m  
Finish node, manhole, reference: HOL, Manhole-3

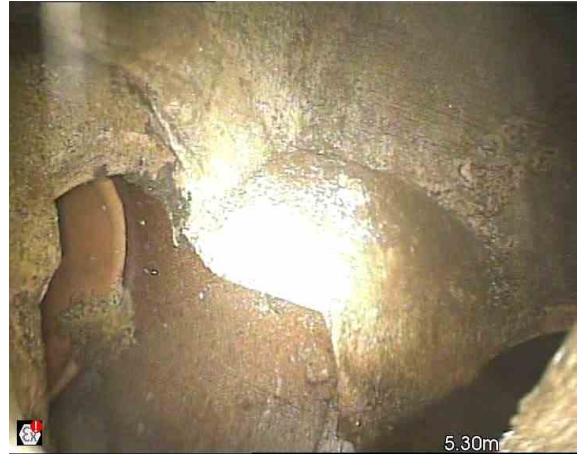
MH4X\_d37e2720-9af4-4fd0-a4cf-d79205e8e24a\_20241204\_1  
00757\_651.jpg, 00:00:29, 5.30 m  
Finish node, manhole, reference: Discharge, Manhole-5

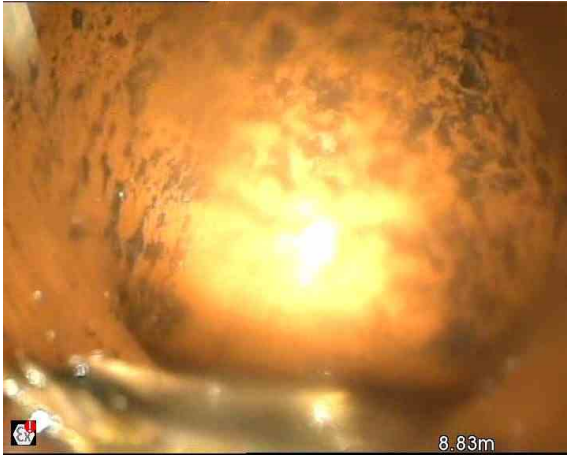
HOLX\_2a28ca55-e4d0-4381-8dd3-884fbc891533\_20241204\_  
120341\_377.jpg, 00:00:45, 9.00 m  
Finish node, gully, reference: HOL

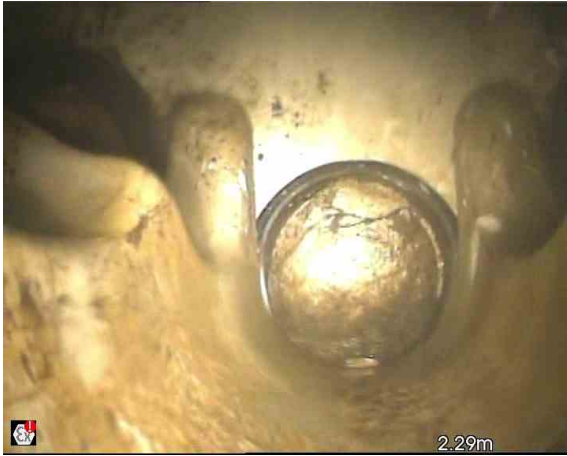
HOLX\_8c0b2557-16c8-4c16-8d29-e8733d427b37\_20241204\_120528\_669.jpg, 00:00:13, 2.30 m  
Finish node, manhole, reference: HOL, Manhole-5A (unable to find)

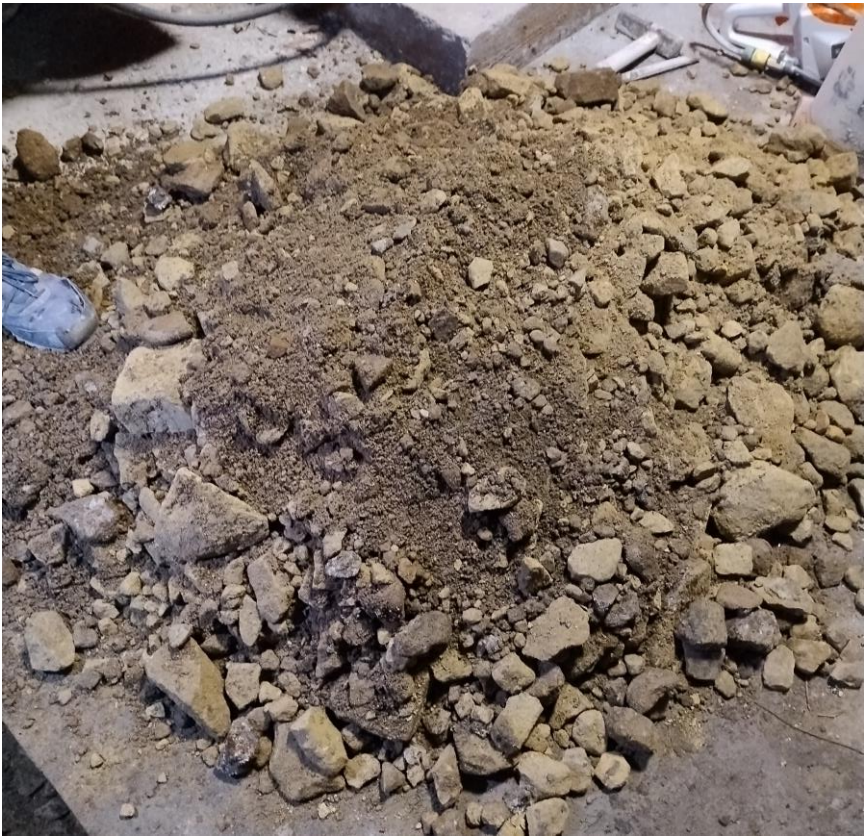
Photo 2 – Detailed view of excavated material.
