# **Ground Investigation Report** [intrusive]

St Andrew's Church, Keighley

| Project Number | 20442 |
| Date Issued | 16 December 2024 (V01) |

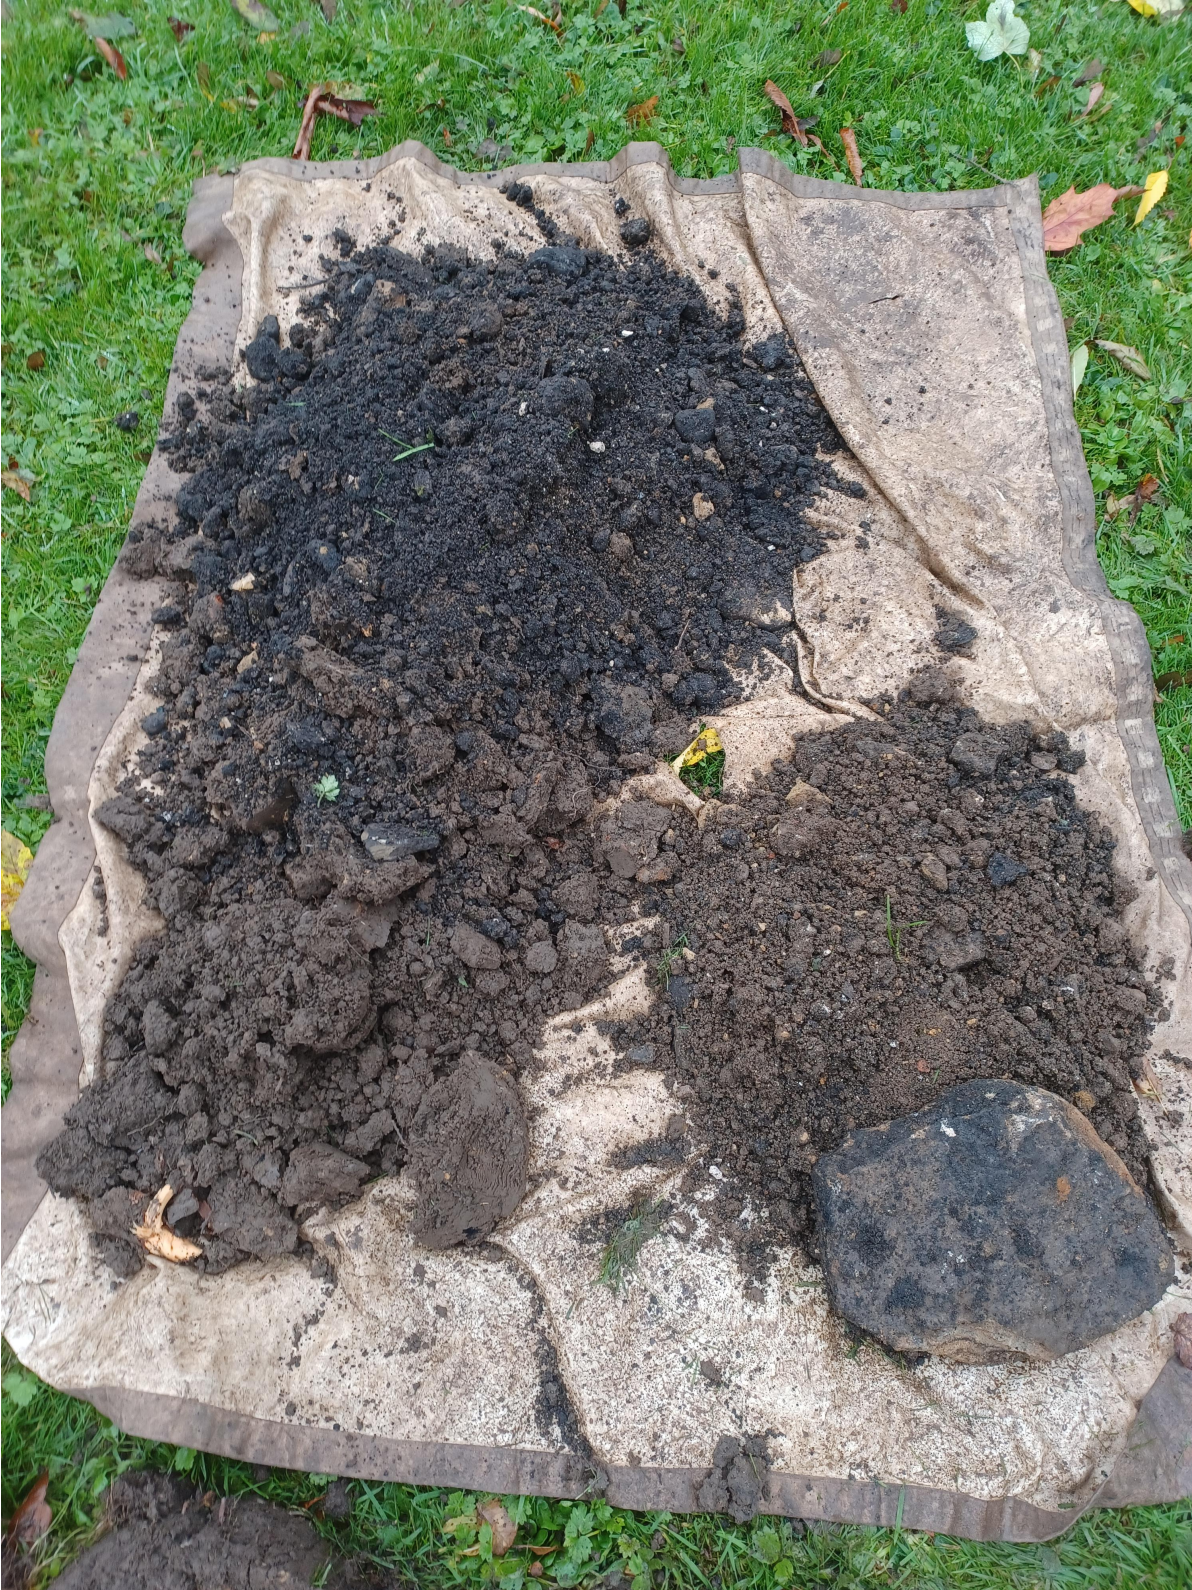
| <b>Remarks</b><br>PURPOSE: Targeting proposed car park extension and ground truthing where DCP103 was completed. TERMINATION: Refusal in sandstone fill. GROUNDWATER: none encountered. STABILITY: stable throughout. LOCATION: taken off freeware software. GL: taken off satellite imagery. OTHER: no evidence of potentially polluting or harmful material. | | | | <b>Method, Plant, Stability, Dimensions</b><br>0.00 - 0.75m HP Hand tools<br>Stable<br>L = 0.30m<br>W = 0.30m | |
